## **RESULTS FROM 99 SEAWATER RO MEMBRANE AUTOPSIES**

**Authors:** *Stephen P. Chesters, Nuria Pena, Silvia Gallego, Maqsood Fazel, Matthew W. Armstrong, Fernando del Vigo*

### **Abstract**

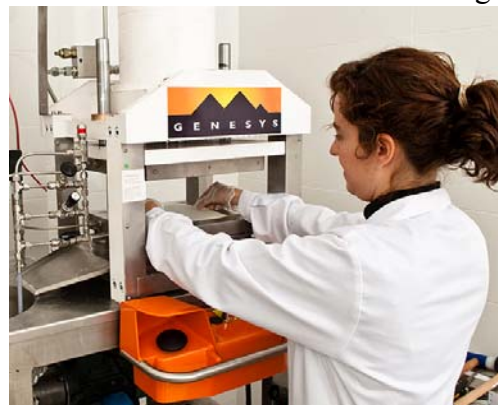
**Fig 1 Flat sheet test rig**

designed flat sheet test rig. [Fig 1] Flow rate and salt rejection are determined and compared to design specifications. Physical damage to the membrane samples is conducted using the methylene blue dye test and oxidation by halogens is tested using the Fujiwara test. The validity of the Fujiwara test has been questioned in some quarters so additional tests using attenuated total reflectance infrared spectroscopy (ATR/FTIR) is carried out. This can provide valuable information related to the chemical structure of membrane and deposits. In the mid-infrared, absorption of radiation is related to fundamental vibrations of the chemical bonds. Internal reflection spectrometry provides information related to the presence of specific functional groups which can determine the presence of halogens. Deposits are identified using elemental determination with the SEM-EDXA system. This is based on analysis of X-rays produced via electron beam excitation of a sample area. This technique allows analysis of a sample in selective areas. The limited depth of analysis (typically a few microns), and the possibility to select the area of interest under the electron beam, allows for local analysis to reveal differences in composition. The identification and measurement of individual peak intensities in the X-ray spectrum can be done with a computerized multichannel analyzer. In addition X-Ray diffraction is carried out to identify crystalline solids by measuring the characteristic spaces between layers of atoms or molecules in a crystal. Each crystalline solid has its unique characteristic X-ray powder pattern which may be used as a "fingerprint" for its identification. X-ray photoelectron spectroscopy analysis (XPS) or electron spectroscopy for chemical analysis (ESCA) is a quantitative spectroscopic technique that measures the empirical formula, chemical state and electronic state of the elements that exist within a material. XPS spectra are obtained by irradiating a material with a beam of X-rays while simultaneously measuring the kinetic energy and number of electrons that escape from the top 1 to 10 nm of the material being analyzed. When the nature of the deposits on the membrane surface is understood then several membrane samples are cleaned with a variety of cleaning solutions at different pH and temperature to assess the best method for cleaning the plant. A full cleaning protocol can then be recommended. The autopsy is written up as a complete report and forwarded to the customer.

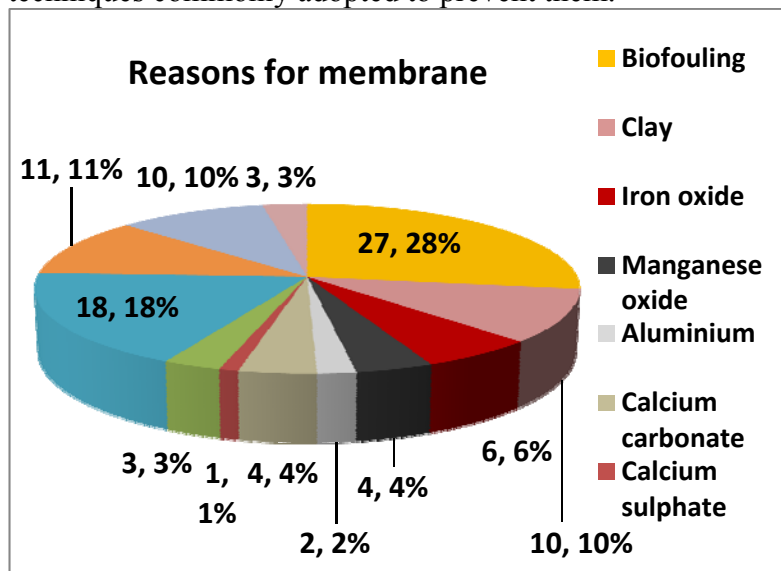
Fig 2 Common reasons for membrane failure

Principle Issues	Number
<b>Biofouling</b>	<b>27</b>
<b>Clay</b>	<b>10</b>
Iron oxide	6
Manganese oxide	4
Aluminium	2
<b>Metal oxides</b>	<b>12</b>
Calcium carbonate	4
Calcium sulphate	1
Silica	3
<b>Scales</b>	<b>8</b>
<b>Oxidation</b>	<b>18</b>
<b>Abrasion</b>	<b>11</b>
<b>Clean</b>	<b>10</b>
Undefined	3
<b>TOTAL</b>	<b>99</b>

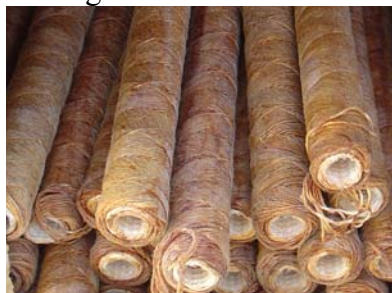
**Fig 3 Iron fouled cartridge filters**

chloride [ $\text{AlCl}_3$ ], Aluminium sulphate [alum,  $\text{Al}_2(\text{SO}_4)_3$ ], Polyaluminium chloride [PAC]. The Israeli Ministry of the Environment has voiced concerns that 3,000 tons of iron per year will be discharged into the sea as a result of coagulant use on desalination plants. Iron fouling has a damaging effect on both cartridge filters and membranes as shown in Fig 3 & Fig 4.

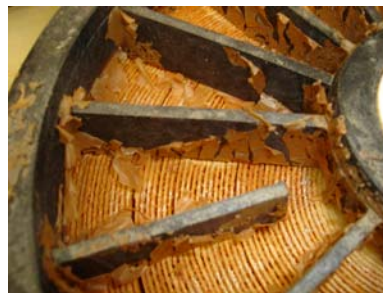
**Fig 5 Iron acrylate fouling**

The use of phosphonate based antiscalants is common place in SWRO plant as they have the distinct advantage of sequestering iron and preventing deposition on the membrane surface. The choice of antiscalant is critical as polymer based products react with iron to form iron acrylate which blinds and irreparably damages the membrane as seen in Fig 5. The autopsy deposit analysis frequently showed small quantities of transition metals such as titanium, vanadium, chromium, manganese, cobalt, nickel, copper and molybdenum. It was reported by Murphy [10] that deacetylation (of CA membranes) was more effective in presence of cobalt and ruthenium, moderately in the presence of iron, nickel, rhodium, palladium and silver, and slightly in presence of copper and gold salts. The source of these metals is thought to be as a result of plant corrosion but may also be due to impurities found in iron salt coagulants. Work conducted by Dr. Nabil Nada of SWCC demonstrated an increased likelihood of membrane oxidation when using poor grade ferric chloride coagulant due to the presence of transition metals which catalysed the oxidation reaction.

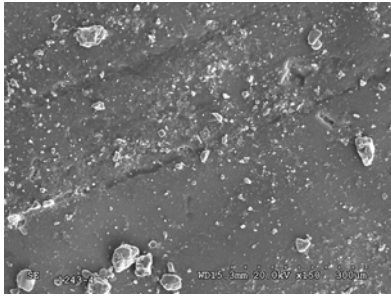
**Fig 6 Spacer indentation**

Due to the high operating pressures of sea water RO plant (50-70 bar) there is a high incidence of abrasion damage on the membrane surface. Damage can occur due to the feed spacer being pressed into the membrane due to excess pressure often as a result of fouling and/or scaling within the membrane element. Using scanning electron microscopy the marks left by the feed spacer can clearly be seen Fig 6. This results in increased salt passage, lower permeate quality and a higher than expected flow rate. Abrasion can also occur when particles are drawn across the membrane surface. The particles are often from the filter media which has been inadvertently washed on to the membranes during commissioning. Also metallic particles (corrosion by-products or welding particles) from pumping and pipes have been identified. Sand and anthracite particles are particularly damaging as shown in Fig 7. Poorly designed cleaning rigs and practices can contribute to membrane abrasion. Inadequate filtration of the cleaning solution results in the circulation of particulates during cleaning resulting in damage to the lead elements. Some algae can be less than 5 micron in size and pass through the cartridge filters. Their exoskeletons are made from calcite or silicon and can also cause abrasion of the membrane surface.

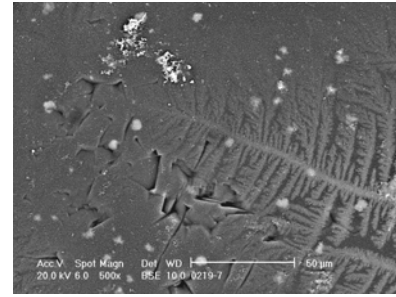
**Fig 8 Scale indentation**

Figure 8 shows the indentations into the membrane surface left behind when calcium carbonate scale has been removed by an acidic clean. This demonstrates that even when cleaned successfully membranes may not work to their original design specification due to physical damage.

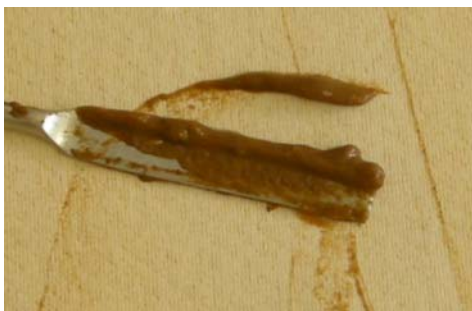
**Fig 9 Clay fouling on a membrane**

Alumino-silicate fouling was found in one third of the sea water membranes autopsied. Ten percent of membranes were failing primarily due to clay deposition [Fig 9]. Clay is the by-product of chemically weathered rocks and is ubiquitous in all waters around the world. Clay minerals are part of the Phyllosilicate (sheet structures) subclass of minerals. Structurally they are composed of tetrahedron rings linked by shared oxygen atoms to other rings in a two dimensional plane forming a sheet-like structure [Fig 10]. These sheets are connected to each other by weakly bonded layers of cations which often have water and other neutral atoms or molecules trapped between the sheets giving clay their soft compressible nature. The resultant crystal structure is flat and plate like. According to Swaddle [11] we refer to them as aluminosilicates when some of the  $\text{Si}^{4+}$  ions in the silicates structure are replaced by  $\text{Al}^{3+}$  ions. For each  $\text{Si}^{4+}$  ion replaced by an  $\text{Al}^{3+}$ , the charge must be balanced by having other positive ion such as iron, magnesium, alkali metals, alkaline earths and other cations. Armstrong [12] concluded that “The structural characteristics of clay minerals mean that operational increases in pressure can compress the deposit resulting in further loss of membrane flux. The test data supports the fact that clay deposits on a membrane surface can produce irreversible damage in terms of salt rejection due to abrasion processes. Improvements in pre-treatment can be considered although practical experience shows that small particulate/colloidal matter ( $< 2 \mu\text{m}$ ) cannot be completely removed from feed streams.” Clay is very difficult to remove completely from the feed stream through filtration. A build up is almost inevitable therefore regular cleaning with specialised clay cleaners is recommended. Clay fouling can be minimized by improving media filters, microfilters and using appropriate flocculants.

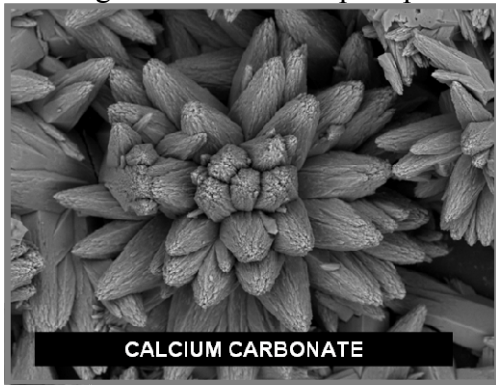
**Fig 11 Calcium Carbonate**

Mineral scale was identified as the major cause of membrane failure in eight percent of the membranes autopsied. However calcium and magnesium deposits were found in 21% of the membranes studied. The scaling species identified included most commonly calcium carbonate, then calcium sulphate and finally

silica. The lack of scale formation may be a result of the common ion effect in sea water significantly reducing the likelihood of precipitation of calcium salts.

More likely is the fact that almost all SWRO plant operate with the use of an antiscalant and acid dosing. The authors conclude that this is the real reason scale is not often found. Some desalters claim that SWRO membrane plant do not require the use of antiscalant, but this seems to contradict the advise of the membrane manufacturers and the best practice on the vast majority of plant in operation. The authors in a literature search and contact with plant operators failed to identify any significant plant that were operating without either acid or an antiscalant. The daily quantities in kg of 95% sulphuric acid required to reduce a sea water pH of 8 on very large plants is shown in Table 2. This is based on a standard sea water chemistry and plant details as shown in Table 3. This data correlates well with actual operational use quantities.
