RESULTS OF A NEUTRAL PH CLEANER THAT REMOVES COMPLEX FOULING AND METALS FROM MEMBRANES

Authors: Nuria Peña García, Javier Rodriguez, Fernando del Vigo, Matt Armstrong, Max Fazel, Stephen Chesters

Presenter: Nuria Peña García
Laboratory Manager – Genesys Membrane Products S.L. – Spain
npena@genesysro.es

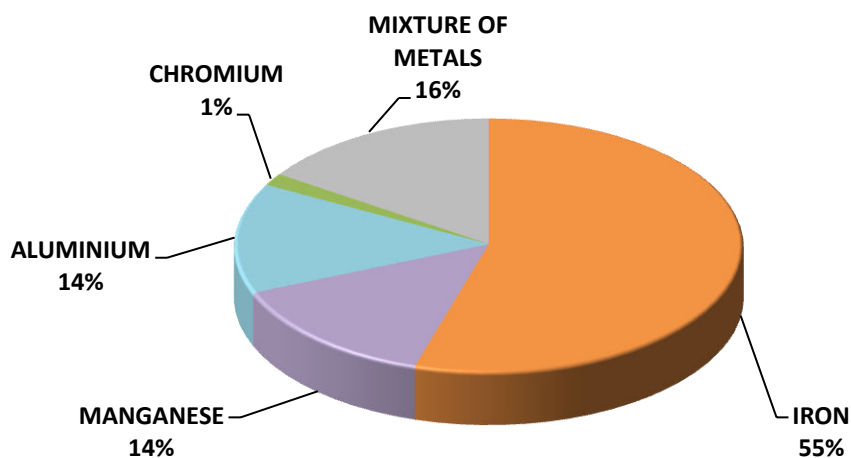
Figure 1.- Main metals detected during autopsies

Considering the data obtained from the autopsies carried out by the authors, main types of metals detected on RO membranes surface are: iron, aluminium and manganese. Following figure 1 shows the percentage of membranes which showed these and other metals as main component of fouling.

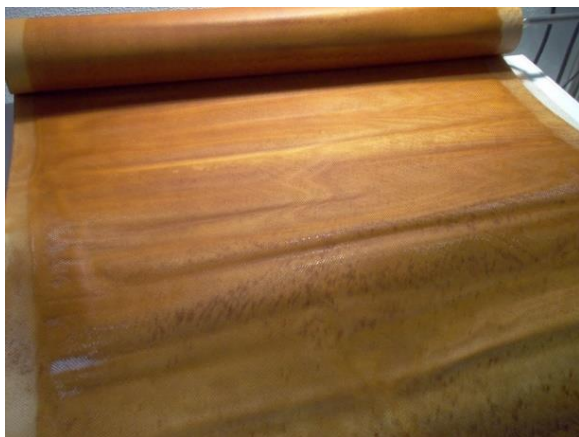
Photograph 1.- RO membrane surface with main presence of iron (as iron oxide)

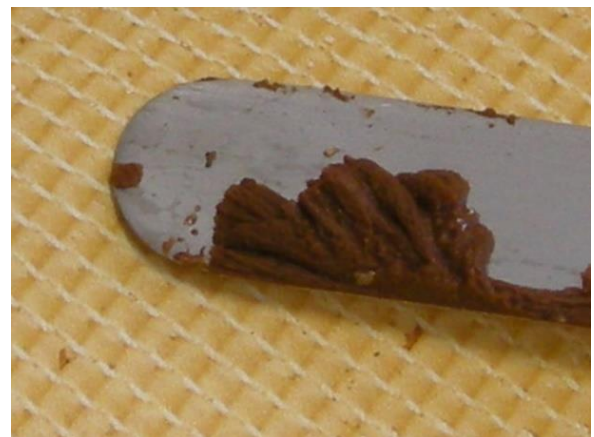
Photograph 2.- Detail of fouling with main presence of iron (iron oxide).

It commonly shows a dark orange color

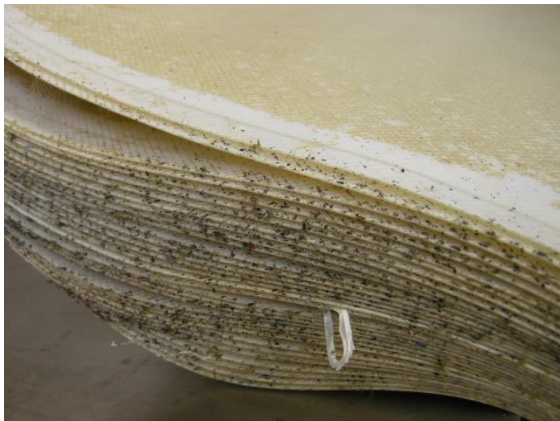
Photograph 5.- Massive presence of corrosion drags at membrane feed end

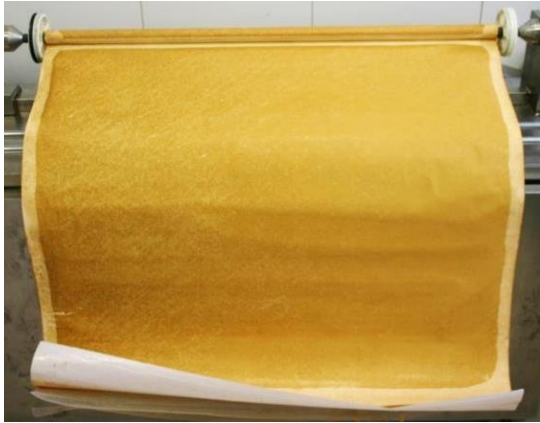
Photograph 7.- RO membrane surface with main presence of aluminium. It doesn't show any specific color different than the rest of fouling components.

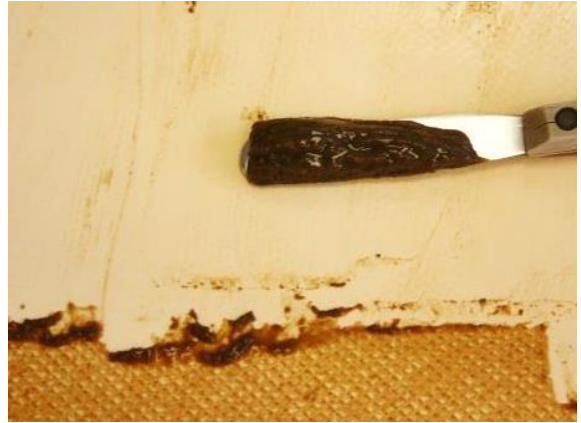
Photograph 8.- Detail of fouling with main presence of aluminium. It commonly appears mixed with organic matter and shows the color of the mixture.

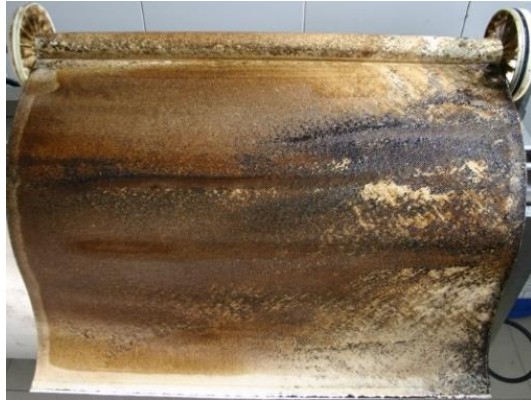
Photograph 11.- RO membrane surface with main presence of manganese fouling

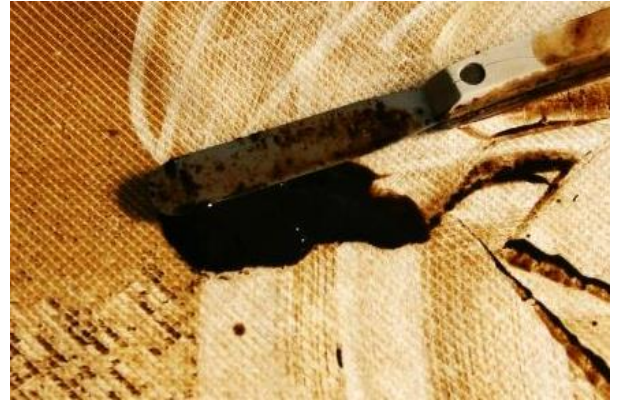
Photograph 12.- Detail of fouling with manganese: very dark brown color (MnO₂)

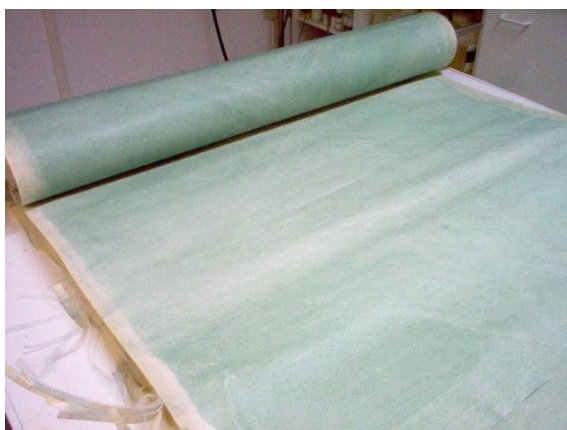
Photograph 15.- RO membrane surface with presence of chromium: green color

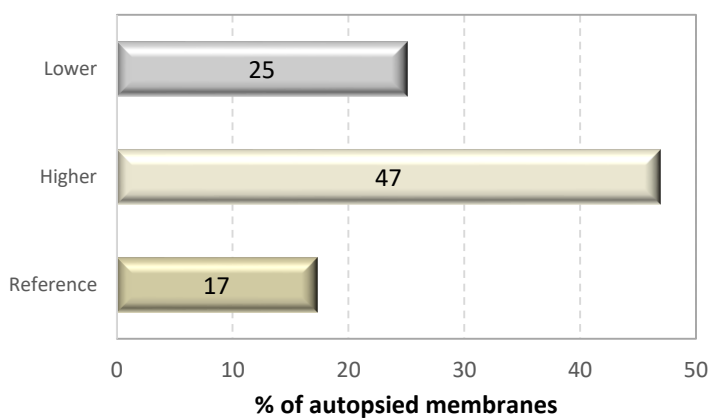
Figure 2.- Permeate flux performance of membranes with metals as main fouling component.

Considering autopsied membranes performance, when there is presence of fouling on RO membranes surface, a lower permeate flux would be expected. But when successful cleaning procedures are not applied in time and membranes keep operating with presence of fouling on the surface, an irreversible damage is commonly produced. Thus, figure 2 shows how during the autopsies included at this study, some membranes showed a permeate flux equal than reference and around a 25% a flux lower than reference, but the 47% of the membranes with a main presence of metals gave a higher flux than reference. This behavior is characteristic of damaged membranes. On the other side, most of the membranes with metals as main component of fouling showed a lower salt rejection than reference (see figure 3).

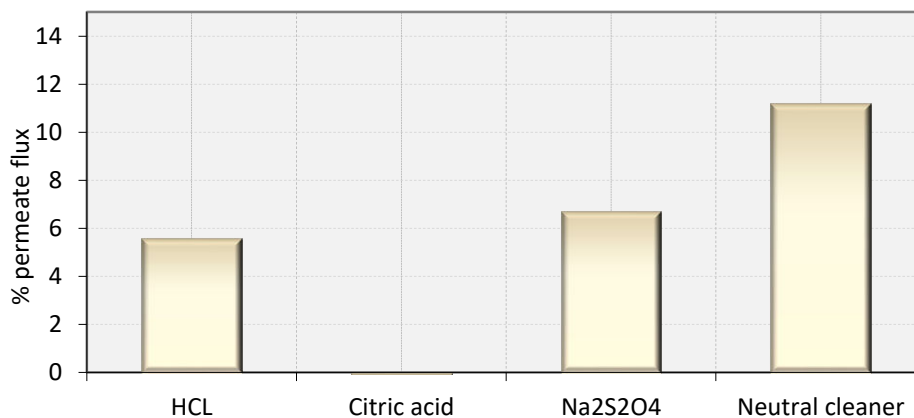
Figure 6. Permeate flux improvement percentage obtained during cleaning tests for iron removal.

Figure 6 corresponds to the graphical representation of permeate flux improvement percentage, which is directly related to fouling removal. Presence of aluminosilicates on membrane surface made it quite difficult to obtain a significant removal of iron but, in any case, they demonstrate that the neutral cleaner achieves a significant permeate flux increase and that it can be compared to other conventional cleaners performance which work at lower pH values.

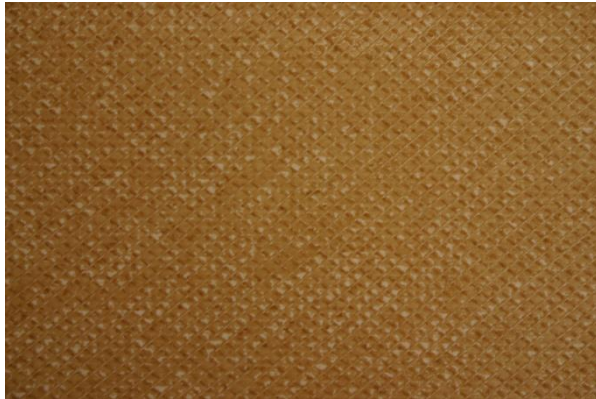
For this study, chosen membrane was from a pilot plant with dosing of a coagulant based in aluminium. Following photograph shows a general view of this membrane surface, which showed a significant presence of fouling composed of biofilm (56.6%) and around a 24% of the inorganic component as aluminium. Besides, presence of aluminosilicates and small percentages of other elements were detected also (see EDX spectrum at figure 10).

Photograph 21.- General view of membrane surface with significant presence aluminium

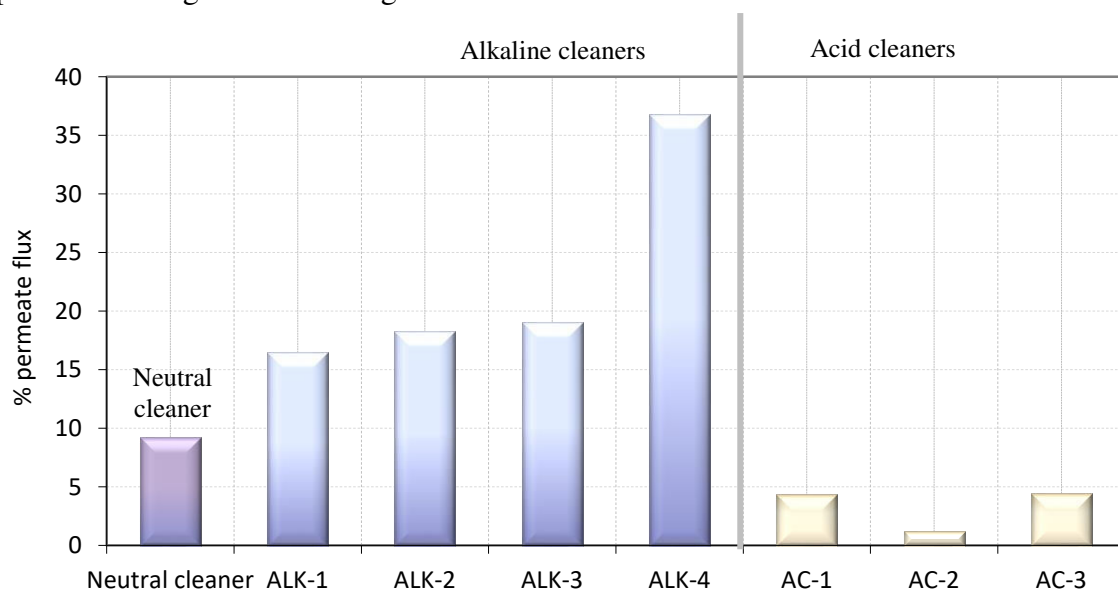
Figure 11. Permeate flux improvement percentage obtained during cleaning tests for aluminium removal

Following figure 11 includes the results obtained during these tests. As it can be observed, permeate flux improvement was higher for alkaline cleaners and Neutral cleaner achieved also a higher permeate improvement than acid cleaners. Photographs 23 and 24 correspond to membrane coupons obtained after a three step cleaning (alkaline-acid-alkaline) and two step cleaning procedure (alkaline-neutral cleaner) respectively. As it can be observed, both membrane coupons show a significant fouling removal.

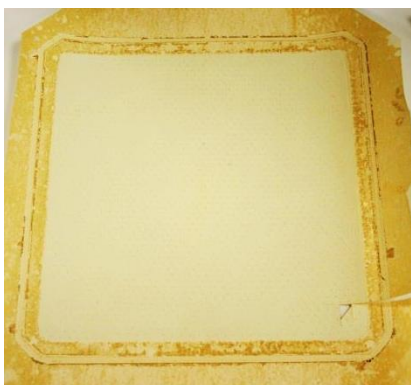
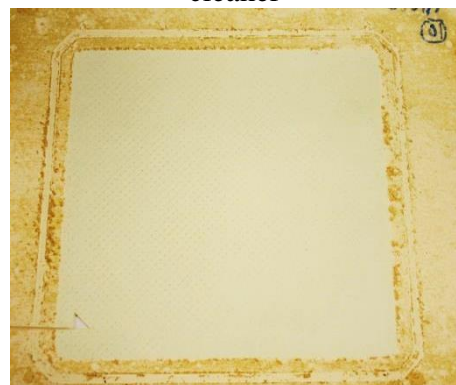
Photograph 23.- Membrane coupon after three steps cleaning (alkaline-acid-alkaline)

Photograph 24.- Membrane coupon after two steps cleaning (alkaline-neutral cleaner)

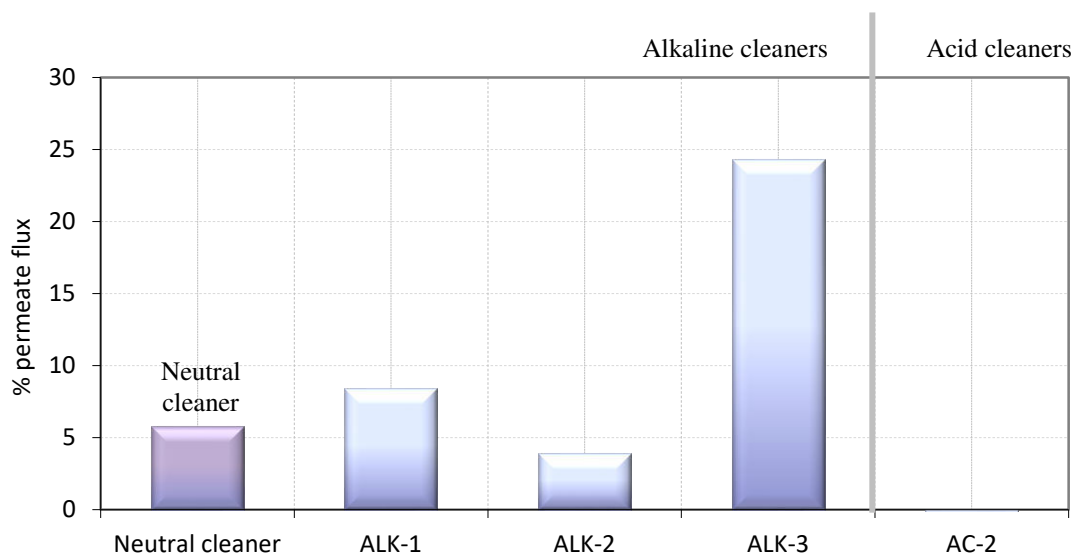
Figure 15. Permeate flux improvement percentage obtained during cleaning tests for manganese removal

Following figure 15 includes the results obtained during these tests. As it can be observed, permeate flux improvement was higher again for alkaline cleaners and neutral cleaner achieved also a higher permeate improvement than acid cleaner. Photographs 27 and 28 correspond to membrane coupons obtained after a three step cleaning (alkaline-acid-alkaline) and two step cleaning procedure (alkaline-neutral cleaner) respectively. As it can be observed, both membrane coupons show also a significant fouling removal.

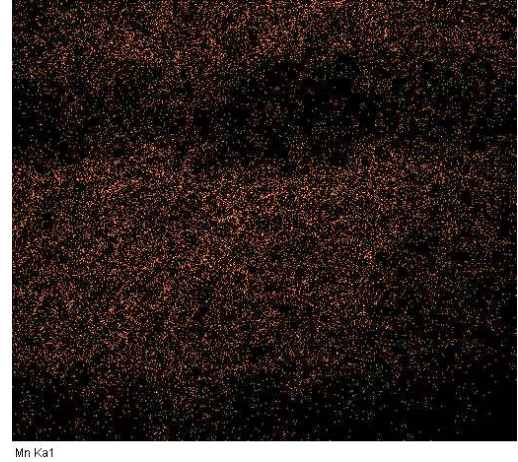
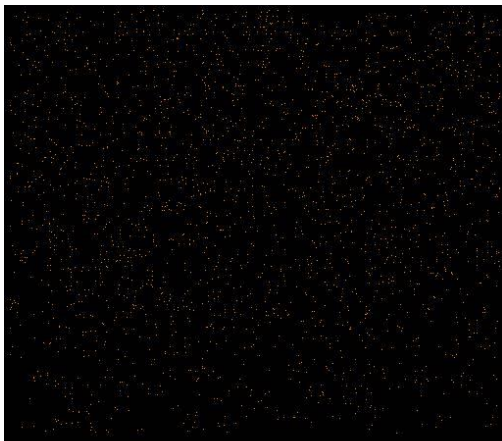
As for the previous samples, additional SEM-EDX analyses were carried out on the membrane coupons obtained after cleaning with neutral cleaner and with the recommended acid. During these analyses a mapping in orange color was applied to check manganese distribution on membrane surface (figures 16 to 18). As it can be observed, a quite similar removal of manganese was achieved with neutral cleaner than with the acid.

Figure 16. Distribution of manganese on membrane surface

Figure 17. Distribution of manganese on membrane surface after cleaning with AC-2 (mild acid)

Figure 18. Distribution of manganese on membrane surface after cleaning with neutral cleaner

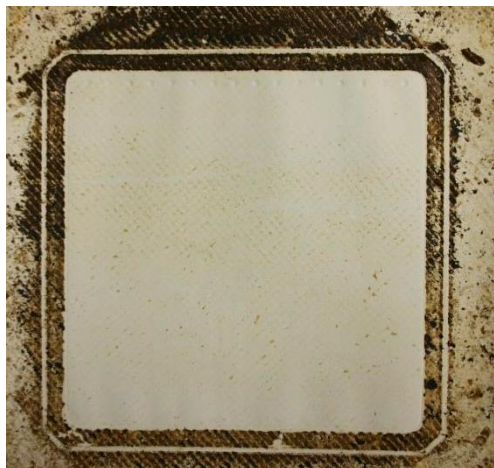
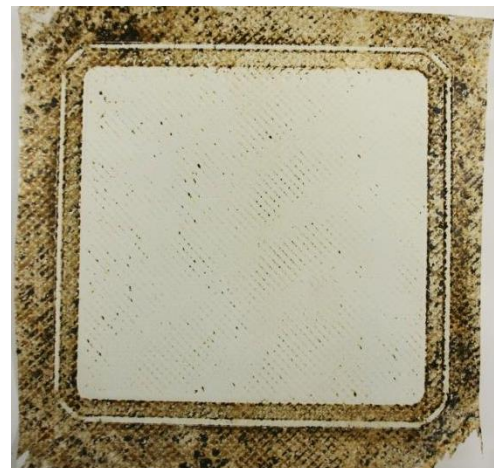
Photograph 27.- Membrane coupon after three steps cleaning (alkaline-acid-alkaline)

Photograph 28.- Membrane coupon after two steps cleaning (alkaline-neutral cleaner)

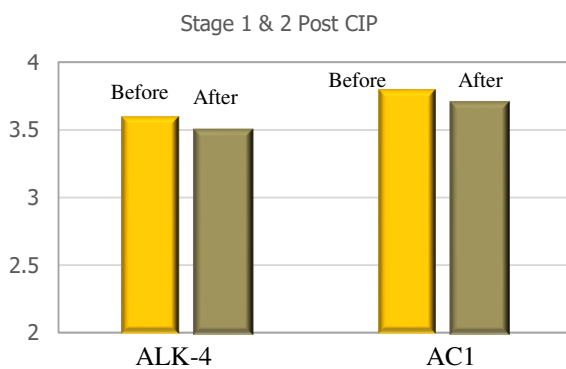
Figure 19.- Changes observed in dp after cleaning with ALK4 (stage 1) and AC-1 (stage 2)

Following graphs show the changes observed in dp on this plant stages. As figures 19 and 20 show how Neutral cleaner achieved a dp decrease that it wasn't reached with ALK-4 or AC-1 at the stages where they were applied.

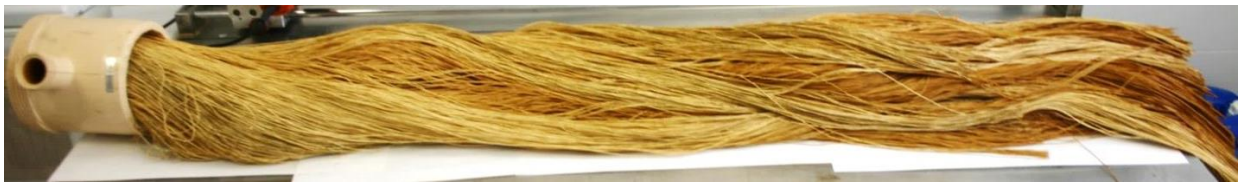
Following photographs show how hollow fiber membrane surface showed a heterogeneous covering of fibers length by fouling.

Photograph 29.- General view of PVDF module

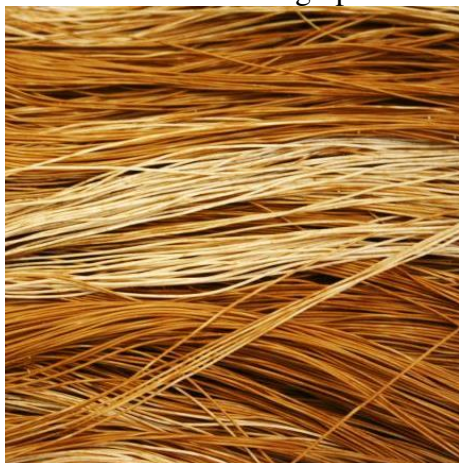
Fibers from this membrane showed presence of an organic covering composed of protein derivatives related to organic matter/biofilm, with iron, aluminosilicates and magnesium and calcium compounds (calcium sulphate). When cleaning tests were carried out on these fibers, results showed that best fouling removal was observed with an acid cleaner (AC-2=photograph 32).

Photograph 30.- Detail of PVDF fibers

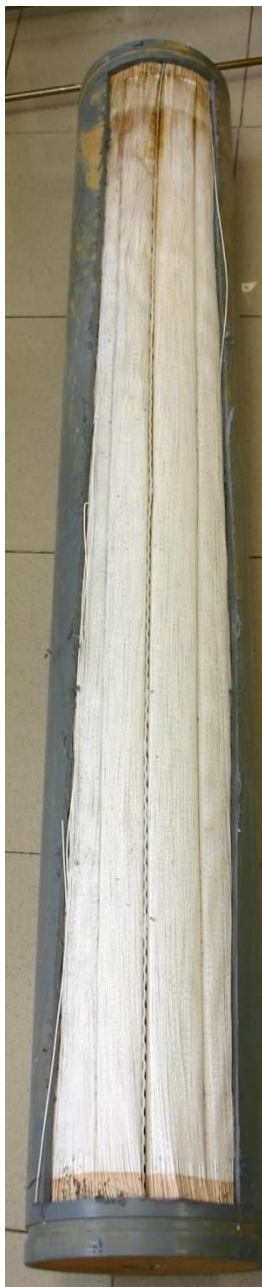
Following photographs show the fibers that compose this module. As it can be expected from UF fibers with inside-out flow path, main presence of fouling was observed on the internal surface of fibers. This fouling was mainly composed of an organic component (biofilm), sodium chloride, iron, phosphorus-zinc, calcium-magnesium and small percentages of other elements which could not be related.

Photograph 35.- General view of PES module

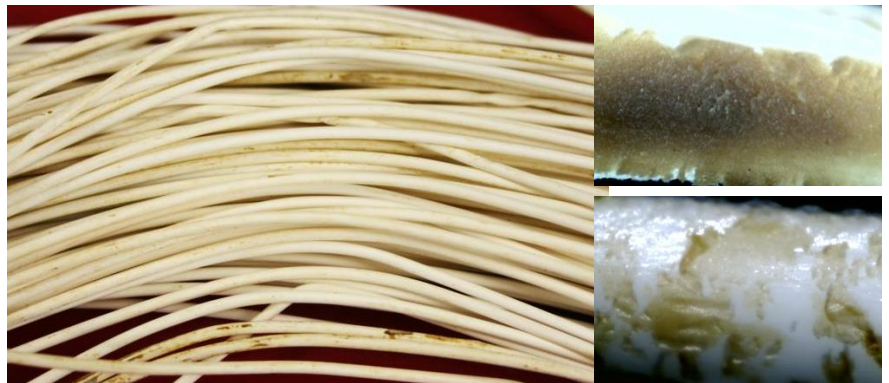
Photograph 36.- Detail of PES fibers (external and internal surfaces)

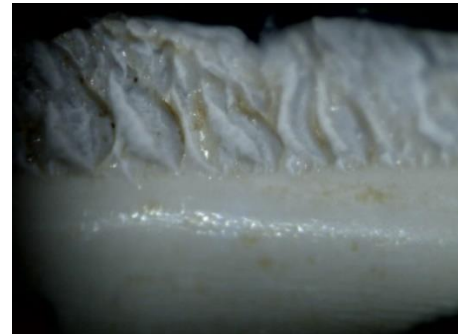
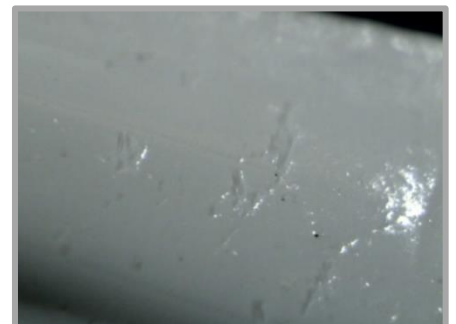
PES internal Surface after cleaning with ALK-2

PES internal Surface after cleaning with ALK-1

PES internal Surface after cleaning with ALK-3

PES internal Surface after cleaning with Neutral cleaner

In this case, cleaning tests showed the best removal of fouling with ALK-1 and neutral cleaner (see photographs 38, 39 and 40). Besides the results obtained by SEM-EDX, during this study it was possible to check fibers permeability and as figure 27 shows, best flux increase was obtained also with neutral cleaner.

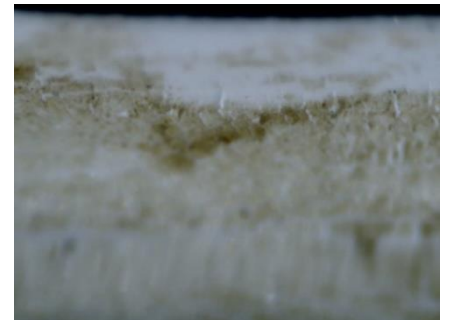
Photograph 38.- Cleaning tests carried out on PES fibers

PES internal Surface after cleaning with AC-3
