A STUDY OF THE PHYSICAL AND CHEMICAL DAMAGE ON REVERSE OSMOSIS MEMBRANES DETECTED BY AUTOPSIES

Authors: Nuria Peña García^a, Fernando del Vigo^a
Stephen Chesters^b, Matthew Armstrong^b, Rachel Wilson^b, Max Fazel^b

Abstract

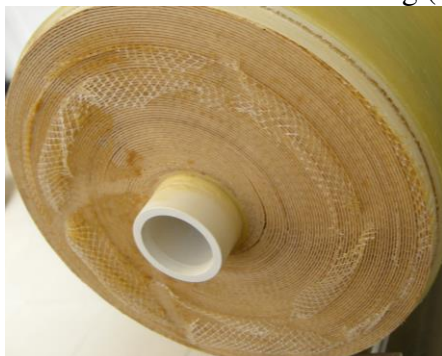
Spacer protrusion

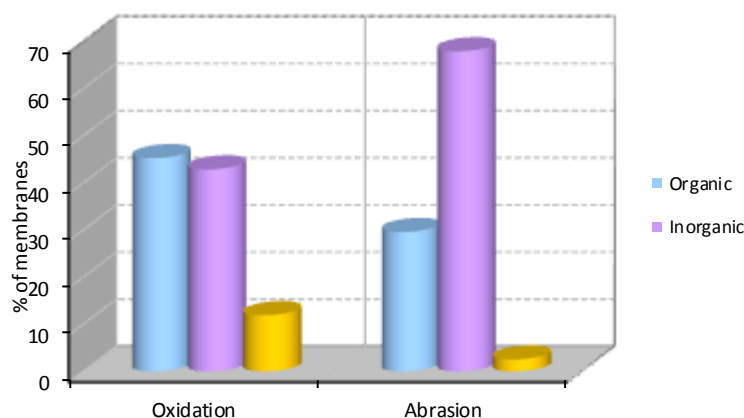
Figure 4.- Damages depending on the nature of fouling

As figure 4 shows, when just the main nature of the fouling is considered, the number of membranes with chemical damages is quite similar for organic and inorganic fouling. However, when physical damages are considered, they are more common when the fouling is mainly inorganic.

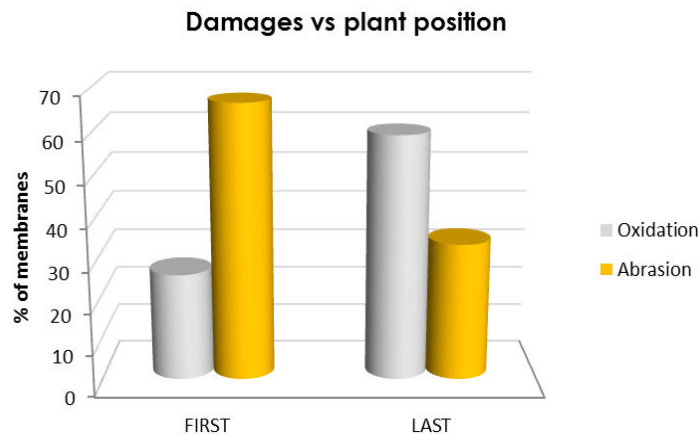
Figure 6.- Damages detected on autopsied membranes depending on site position

Quite related to the composition of the fouling, it is interesting to consider the position of the membranes and the damages observed on them (figure 6). As this figure shows, although both physical and chemical damages can be detected on all the studied positions, abrasion is more common on first positions and oxidation processes on last positions.

The most common types of fouling that are detected on membranes (biofilms and colloidal matter) are commonly related to first positions and, thus it is reasonable to find a higher percentage of damages on first positions. Concerning chemical damages, the first contact of any chemical is with the first position, but once again if we consider that the most common fouling are mostly found on the first positions, the chemicals would damage in a less extent the membranes with less presence of fouling.

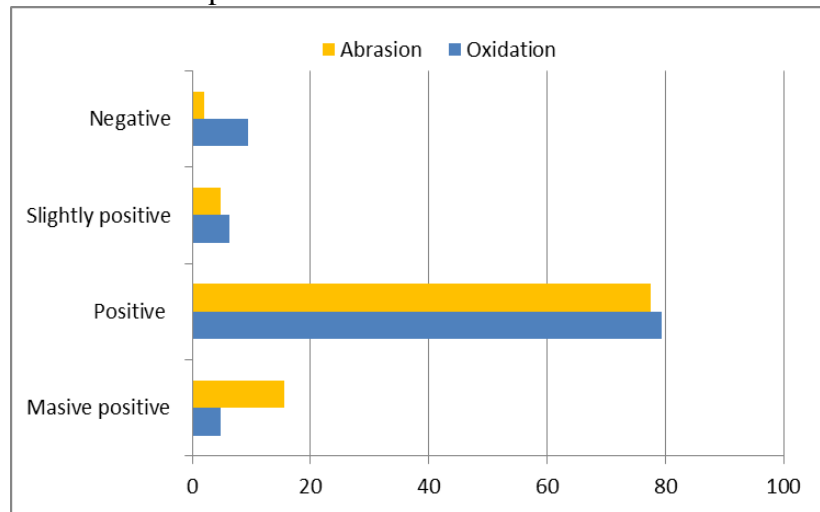
Figure 8.- Methylene blue tests on membrane autopsies.

This test is based on the passage of a high molecular weight compound through the polyamide layer. When presence of this compound is detected on the permeate side of the membrane, it means that the polyamide layer is damaged. As figure 8 shows, methylene blue test was positive for almost the 80% of the membranes with chemical and physical damage. As this figure shows, membranes with oxidation show a higher percentage of membranes with a negative answer to the test and membranes with abrasion a higher percentage with a massive positive.

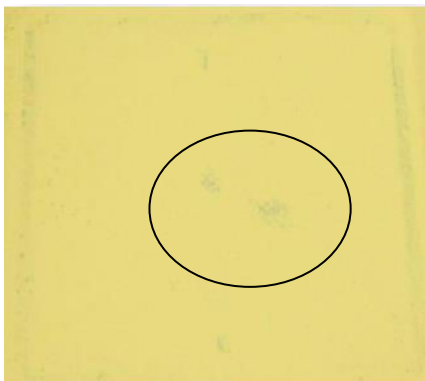
Photograph 1.- Methylene blue test on a membrane with a **severe chemical damage**

For the demonstration of these conclusions, we did some tests on our labs and, as next photographs show we verified that even with a severe chemical damage, methylene blue test is not as positive as with a severe physical damage. Therefore, this test seems to be more sensitive to physical than to chemical damage.

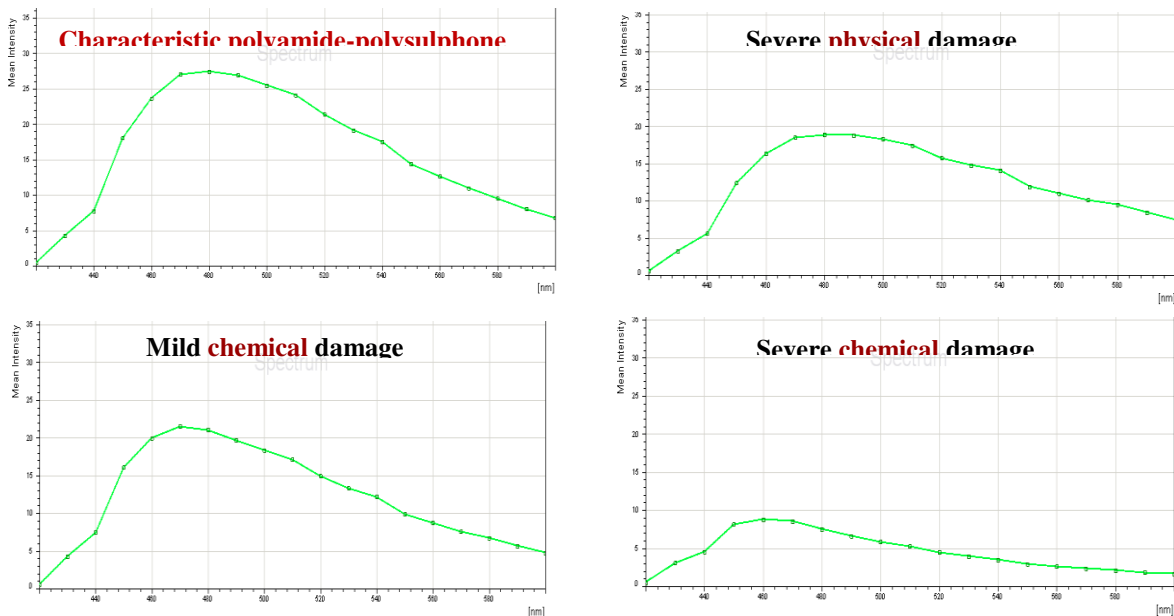
Figure 14. Emission spectra from different membrane damages obtained with a confocal microscope

Therefore, if we compare the spectra obtained with different laser sources on the study of one membrane blank and damaged membranes (figure 14), we can observe a decrease on the intensity of the spectrum maximum with the damages. Although the spectra changes with all the damages studied, this technique seems to be more sensitive to chemical than to physical damages.

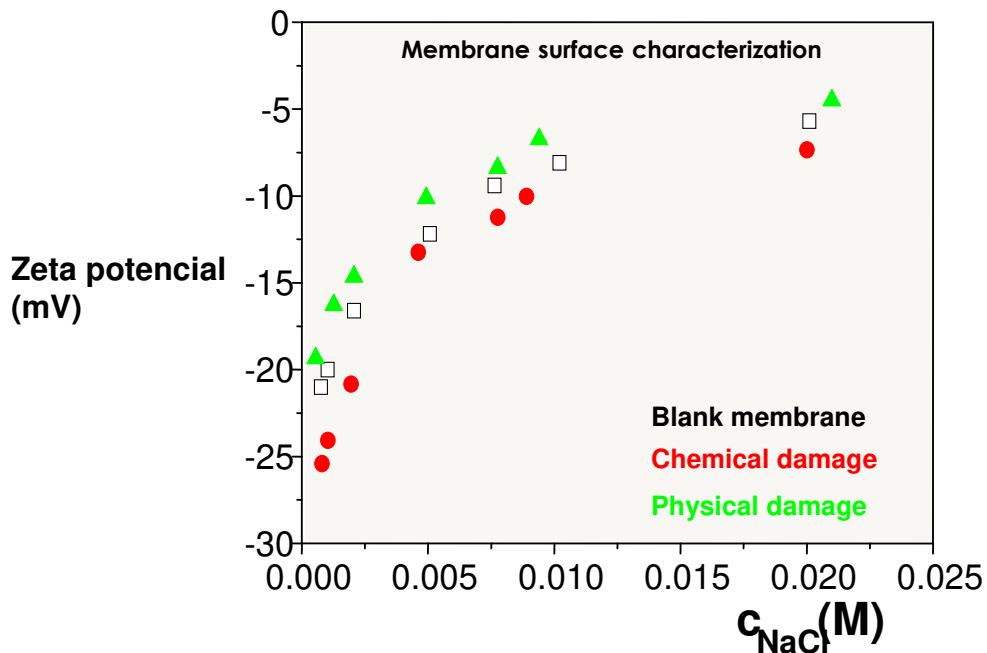
Figure 16. Zeta potential values obtained from membranes with physical and chemical damages

Next figure 16 represents the measurements of zeta potential vs different sodium chloride concentrations. As it can be observed, chemically damaged membrane surface is slightly more electronegative than membrane blank. When the damage is physical, membrane surface shows an opposite effect and lower.
