UF MEMBRANES AUTOPSIES: AN APPROACH TO HOLLOW FIBER MEMBRANES SURFACE

Authors: Nuria Peña García^a, Javier Rodríguez^a, Fernando del Vigo^a, Stephen Chesters^b

^a Genesys Membrane Products, C/Londres 38, Oficina 204, Las Rozas, 28232, Madrid, Spain

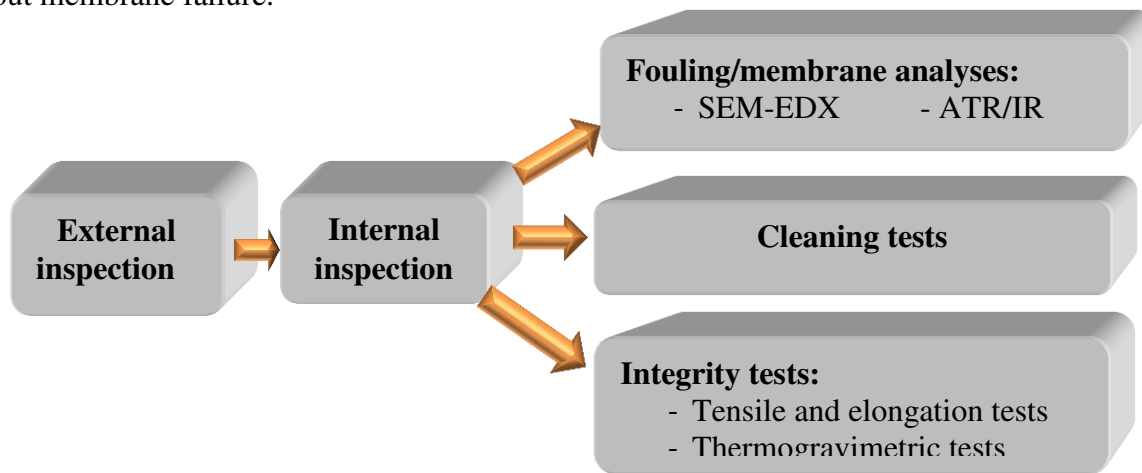
Diagram 1.- Schematic description of main analysis carried out in membrane autopsies

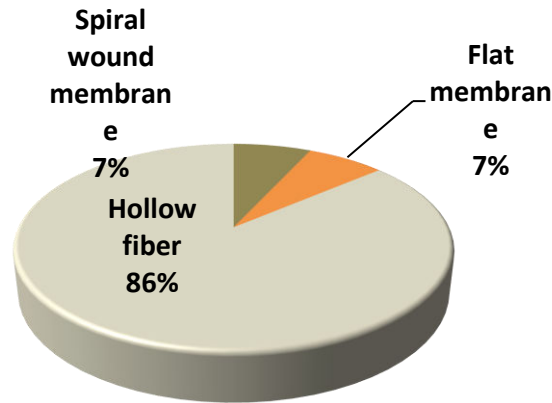
Figure 1.- Different configurations of autopsied UF membranes

UF membranes have different morphologies depending on their applications and characteristics of the influent to be treated. From the different configurations of UF membranes that are available in the market, the most common samples that are autopsied in our labs are hollow fiber membranes (see figure 1).

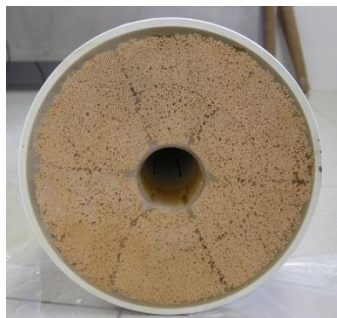
Module end

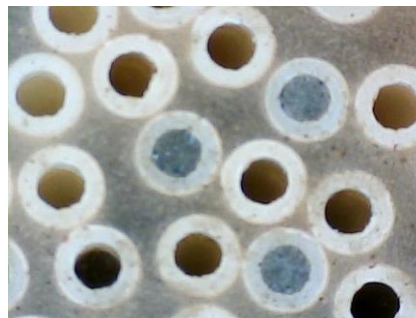
Blocked fibers

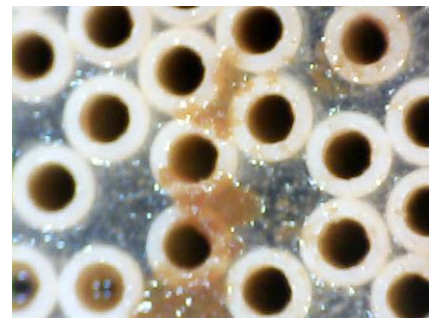
Fouling on module end

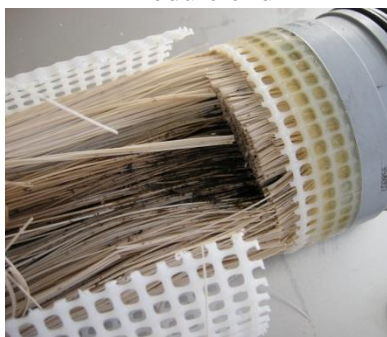
Presence of fouling

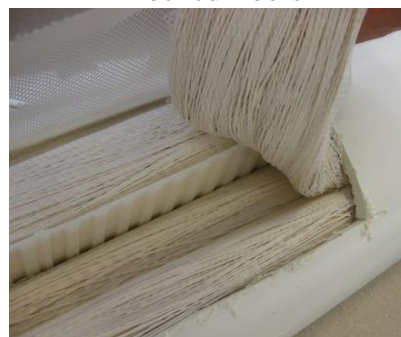
Module configuration

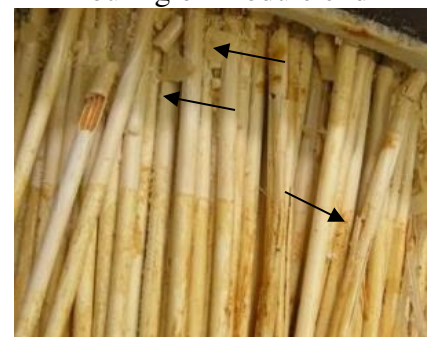
Damages on fibers

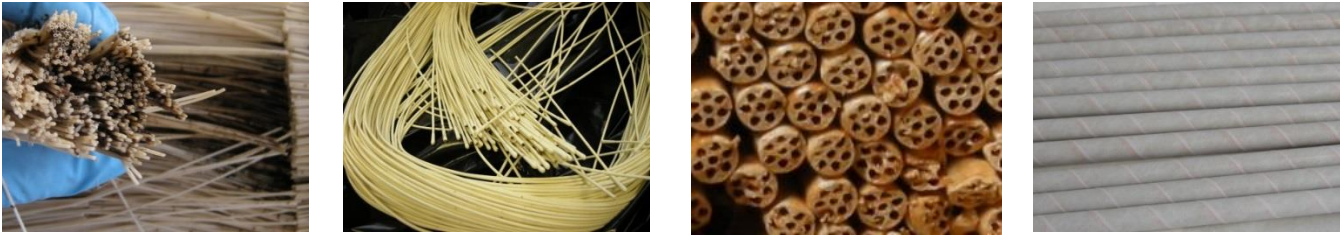
UF hollow fibers membranes have different composition and configuration. The following photographs show some of the different configurations, structures and types of UF hollow fiber samples commonly analyzed in our laboratories.

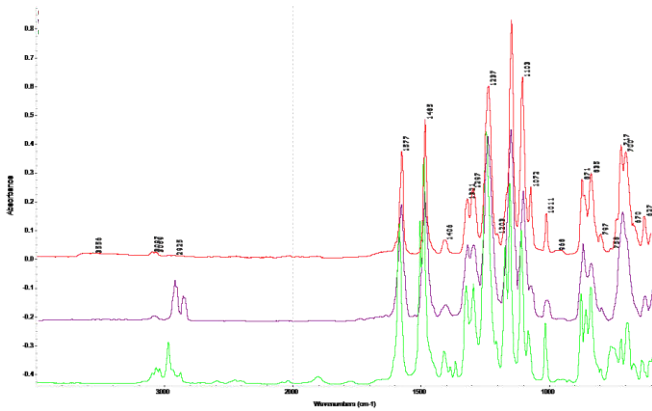
Figure 2. Characteristic PES IR spectra

Both SEM-EDX and ATR/IR allow to verify and to check membranes composition and configuration. Following figures include some IR spectra obtained from different hollow fiber composition. By this technic is possible to verify fibers composition, but also if there is any additional component.

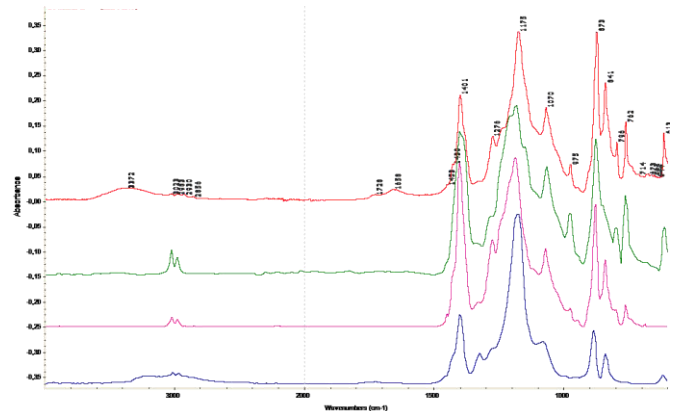
Figure 3. Characteristic PVDF IR spectra

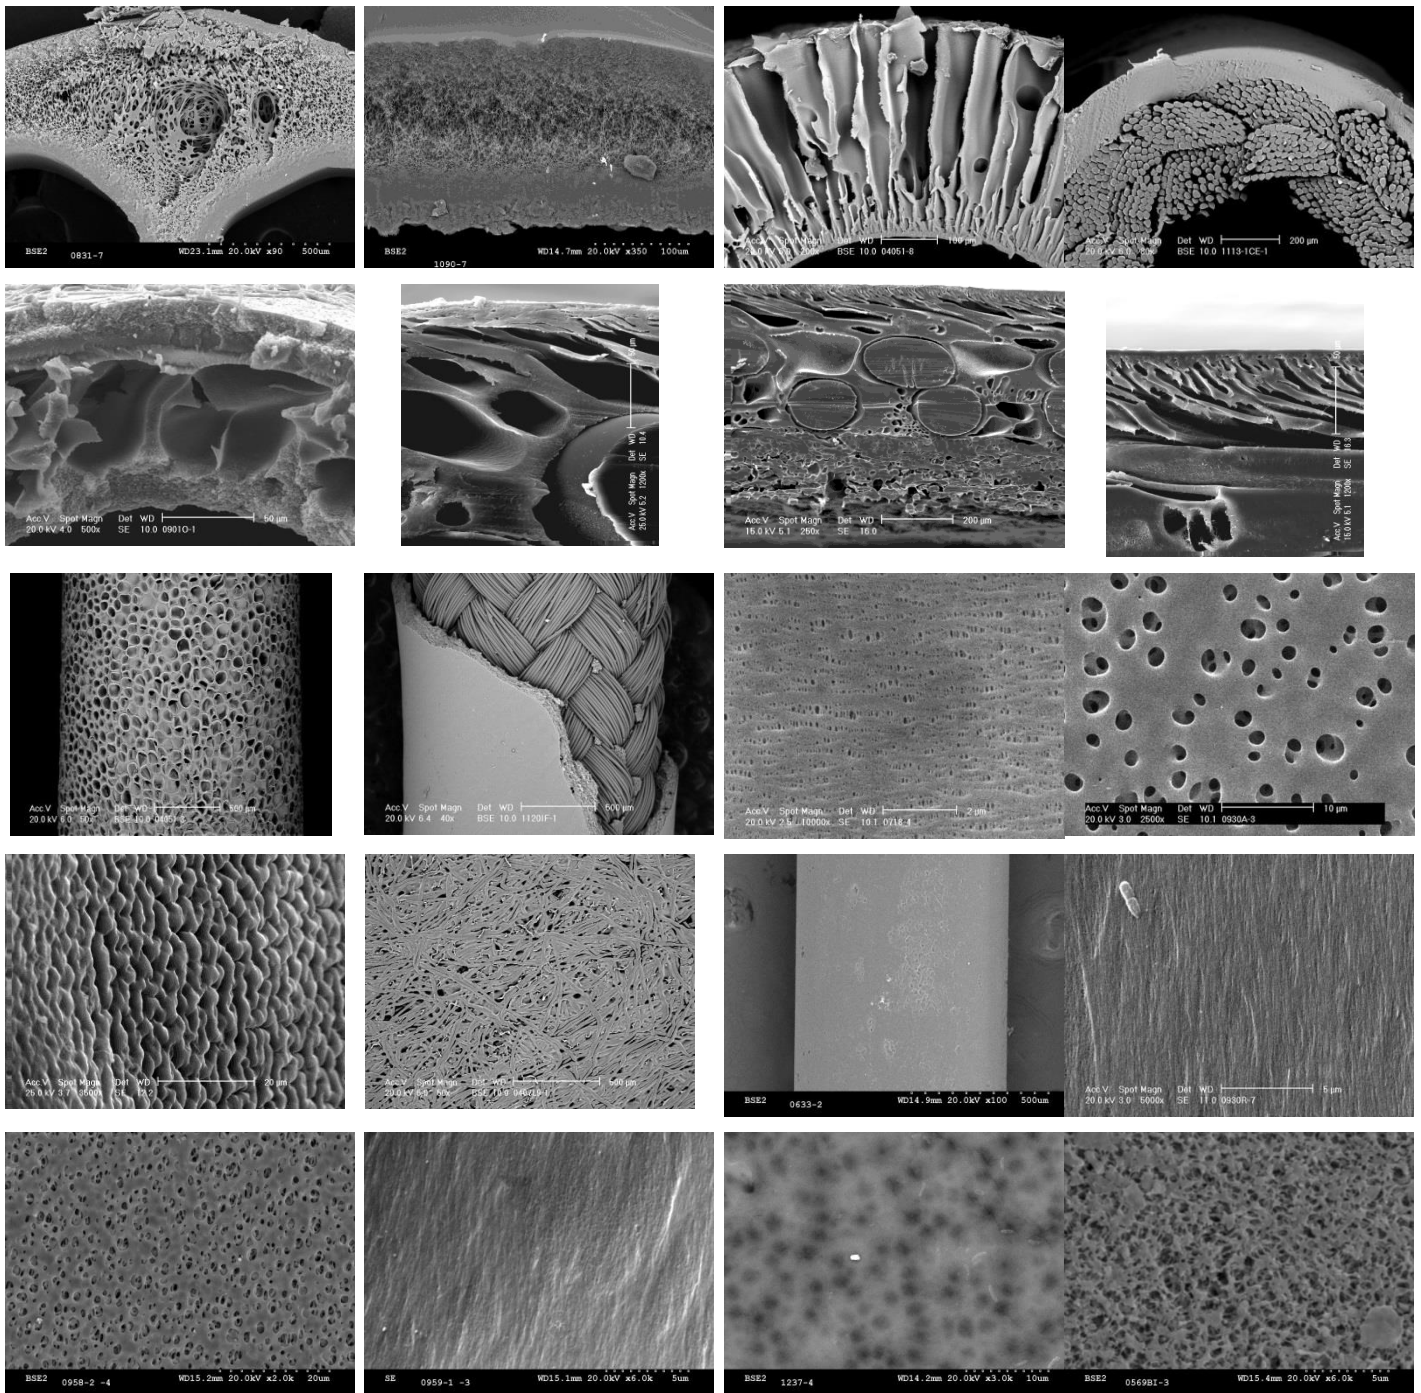
Following microphotographs show different cross section of different UF hollow fibers where different distribution of its components can be distinguished.

Different morphologies and structures of UF hollow fibers obtained by SEM

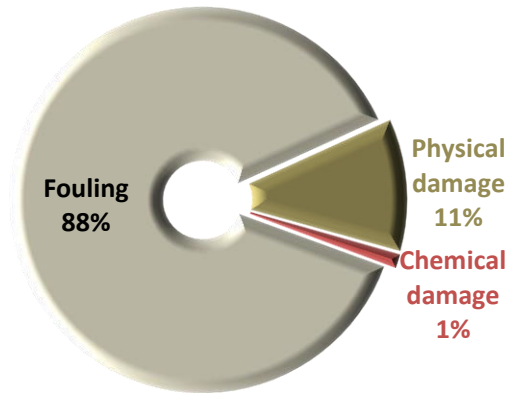
As already explained, it is normal that UF hollow fiber membranes suffer a decline in permeate flux. The best tool to have an accurate diagnosis of membrane failure is a membrane autopsy. Considering the results obtained from 90 autopsies, the following figure 4 shows that most common reason of failure in this kind of membranes is fouling. In this percentage of membranes with fouling, the 63% showed a relevant covering.

Figure 4.- Main failures detected on UF membranes during autopsies

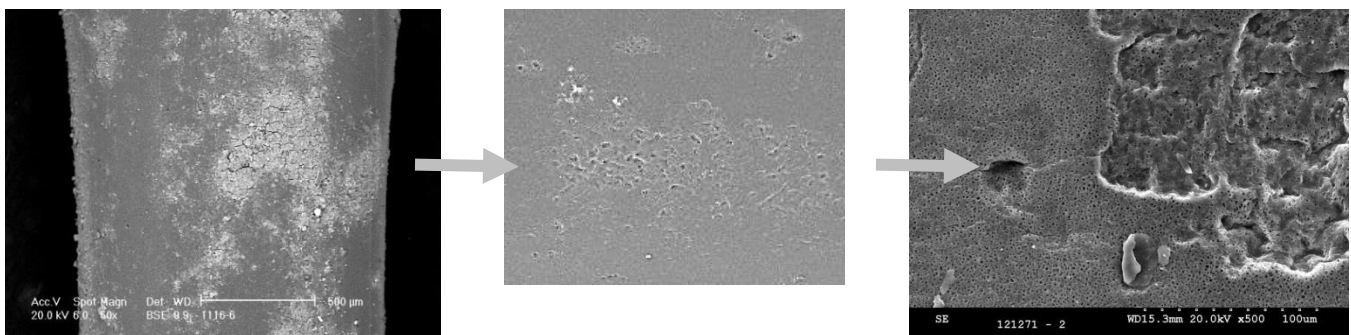
An easy way to check if there is any loss of integrity on hollow fiber membranes is by SEM. Following microphotographs show how a removal of fouling from fiber surface reveals the presence of relevant abrasion marks on its surface. These marks can produce not only failures on product quality, but also a decrease on fiber integrity.

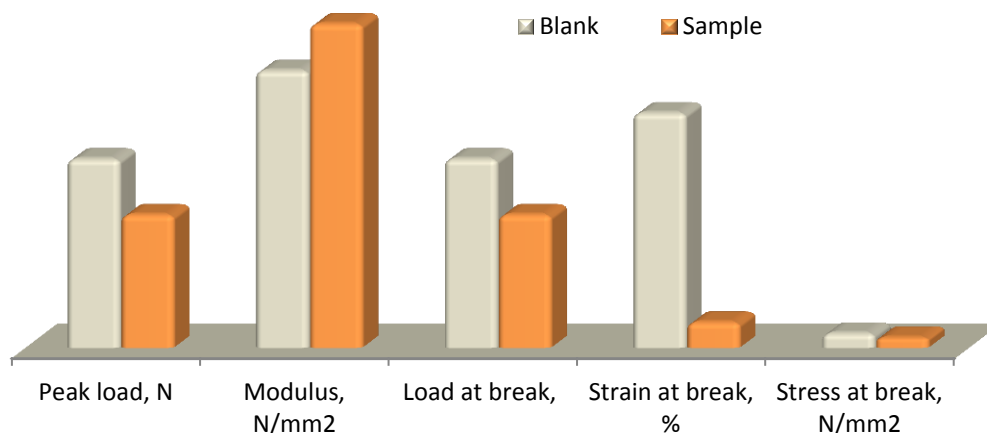
Another important characteristic that reveals a loss in hollow fiber integrity is tensile strength. As an example, following table shows some results obtained from a fiber which didn't show relevant presence of fouling, but a lack in performance. As it can be observed, this fiber had suffered significant changes on tensile parameters when it was compared to a blank membrane which verified that membrane failure was due to these changes on fiber properties.

Figure 5. Mechanical properties of a damaged membrane compared to a membrane blank

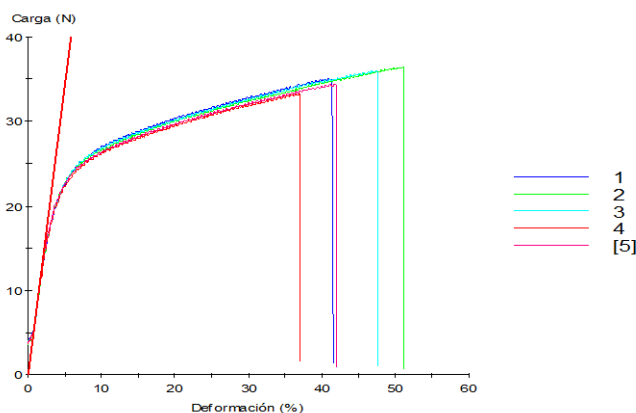
Figure 6. Blank fiber tensile tests

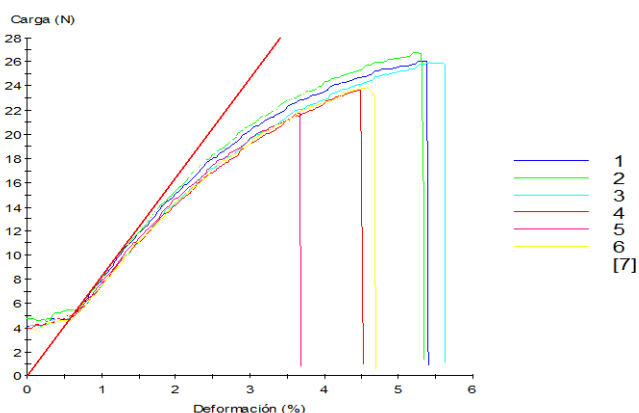
Figure 7. Sample fiber tensile tests

These changes on mechanical properties may be due to different factors. Besides a loss due to compaction or even to abrasion problems due to fouling presence, chemical integrity of hollow fiber membranes can change also. Although chemical solutions are widely employed for cleaning and disinfecting UF membranes, contact with chemicals may play an important role in membrane ageing [7, 8, 9].

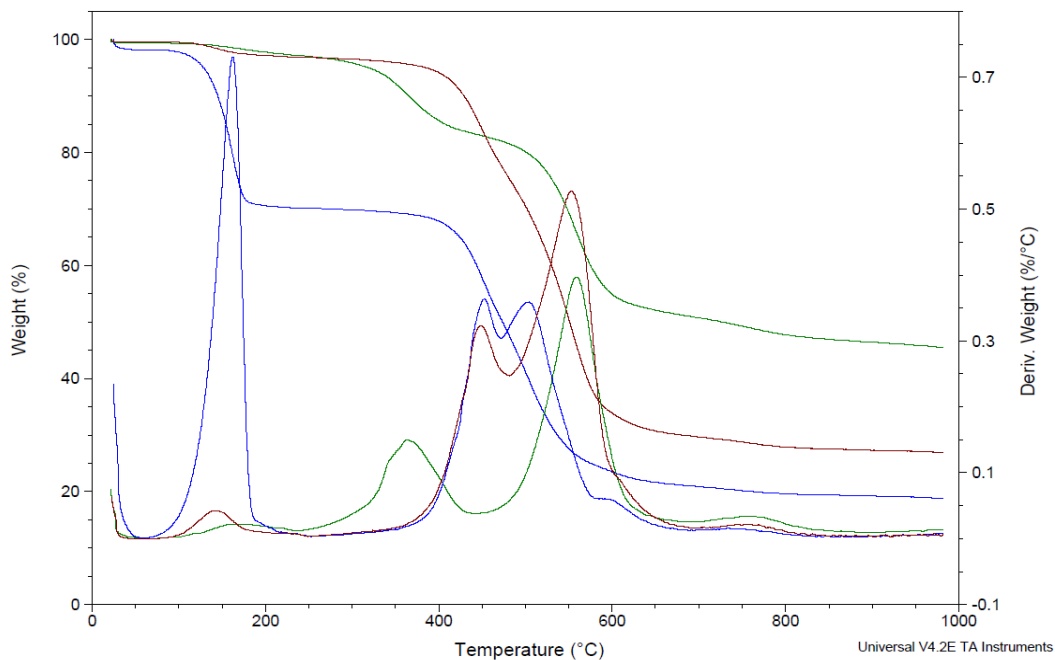
When there is a loss of integrity on UF hollow fiber membranes, it is important to verify chemical integrity. As described during introduction, there are some techniques for testing UF hollow fiber membranes compositional properties as thermogravimetical analyses (TGA). Next figure 8 represents the differences between a membrane with some integrity problems (green line) and a membrane blank (brown line). As it can be observed, membrane sample showed some changes on thermal properties related to changes on fiber chemistry.

Figure 8.- Comparison of curves obtained from the TGA analyses of membrane blank
 Green line-Sample
 Blue line-Membrane blank 1 Brown line-Membrane blank 2

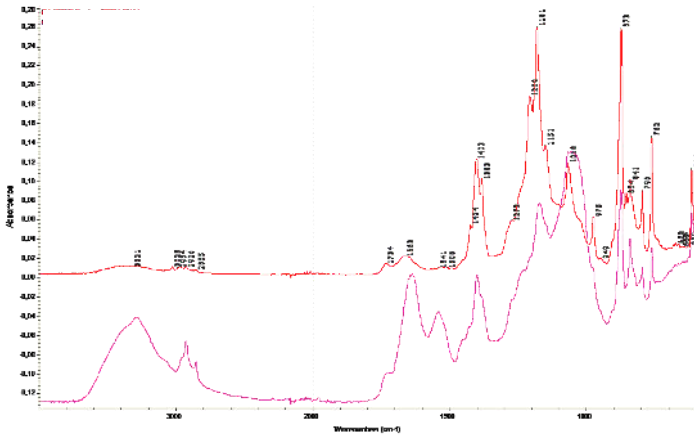
Figure 9. IR spectra of internal and external fiber surface – fouling on external surface

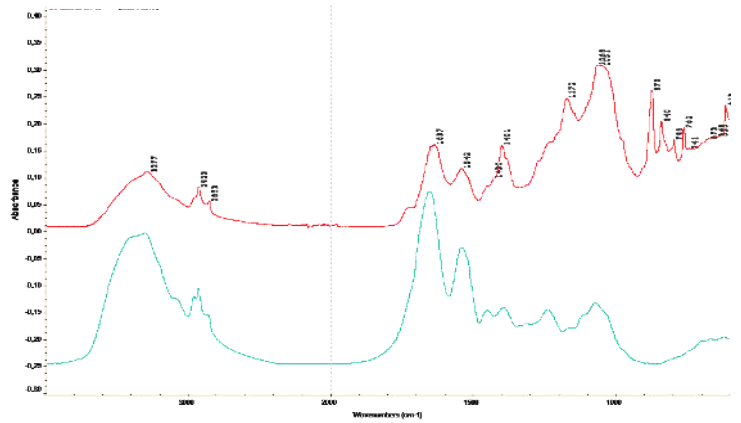
Figure 10. Characteristic biofilm IR spectra

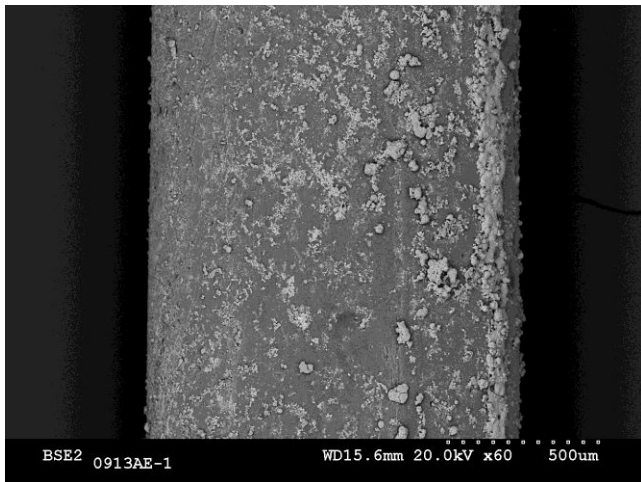
As it can be observed, this fiber showed a relevant presence of fouling, which in any case allowed distinguishing any structure neither on external surface (support surface) nor on the internal surface (filtration surface).

Figure 11. SEM image detail of UF hollow fiber external surface

As already explained in introduction, UF hollow fiber membranes have different configuration and structure, which depends on the sense of filtration. As a media of filtration, the identification of fouling included in figures 20 and 21 was carried out on the filtration side. But the 37.5% of IN→OUT fibers and the 7.7% of OUT→IN membranes, presence of fouling was detected also on the support layer. In most of the cases, fouling was similar on both fiber surfaces filtration side, but more than the 20% of the fibers with relevant presence of fouling on the support component, showed presence of calcium carbonate (example included in figures 11 to 19).

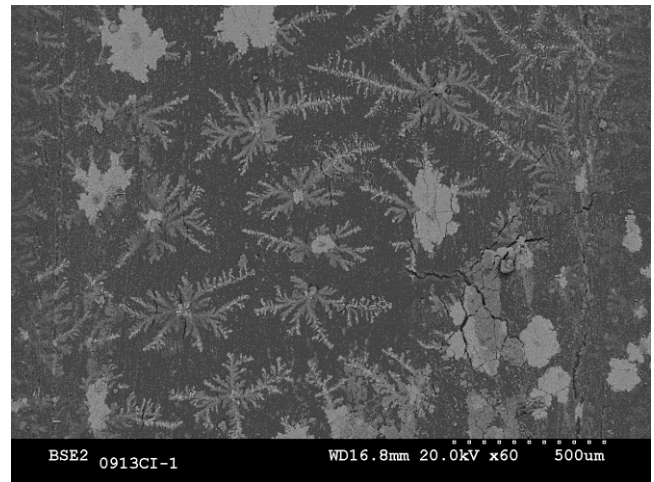
Figure 12. SEM image detail of UF hollow fiber internal surface

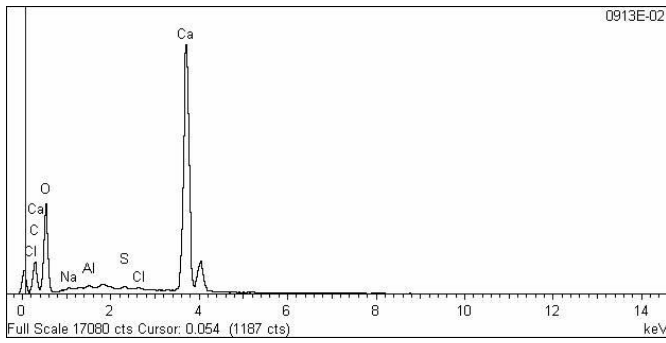
Figure 13. EDX analysis of UF hollow fiber external surface fouling

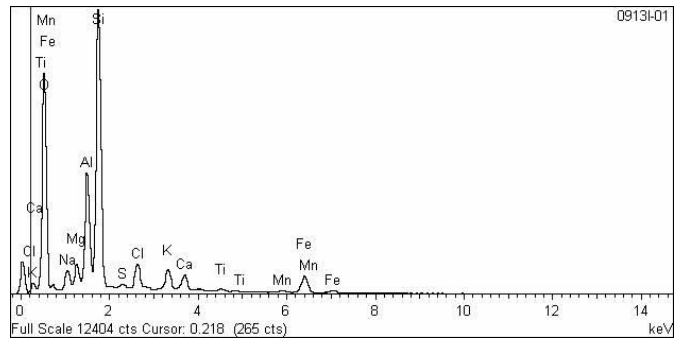
Figure 14. EDX Analysis of UF hollow fiber internal surface fouling

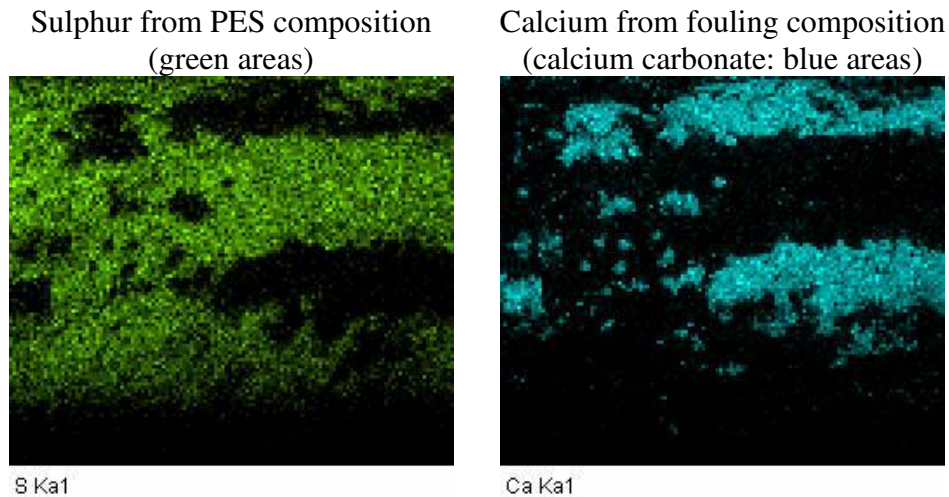
Besides the identification of fouling by this conventional analysis, SEM-EDX allows to get a distribution of each detected component by doing a mapping analysis of the surface. Following microphotographs distinguish the distribution of calcium and silicon as main components of the fouling on both external and internal surfaces.

Figure 15. External surface main components distribution

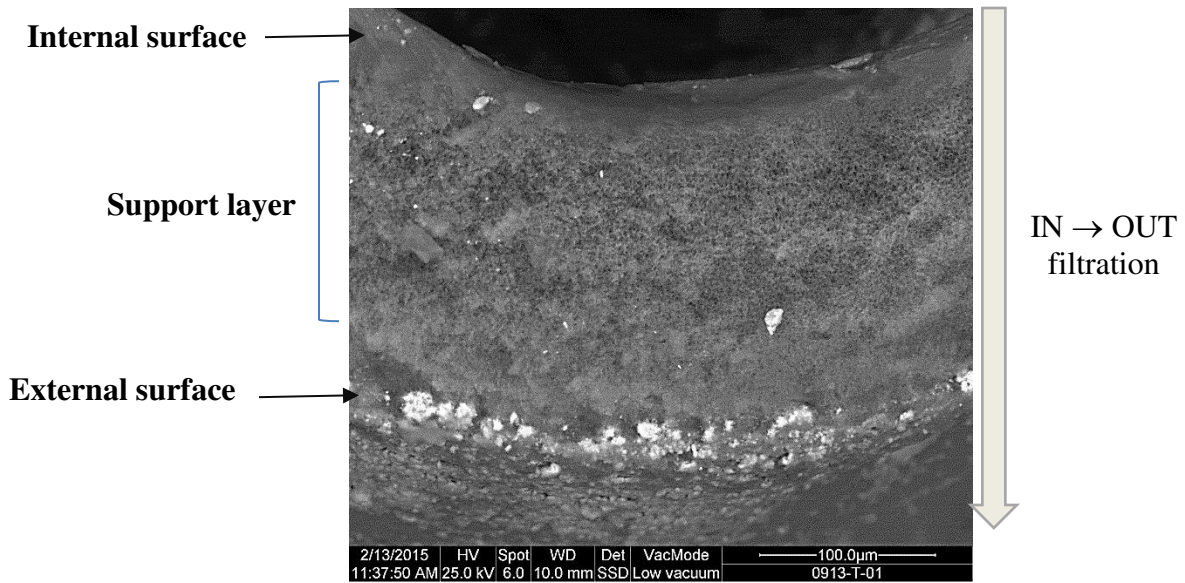
Another very useful application of this analysis on UF hollow fiber membranes is to analyze cross section of fiber membrane.

Figure 16. Detail of UF hollow fiber cross section

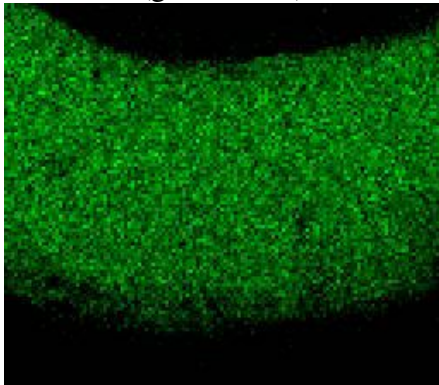
S Ka1

Sulphur from PES fiber composition
(green areas)

Figure 17. UF hollow fiber cross section main components distribution

As figure 17 and 18 verify composition of fouling on both sides of the fiber are different and they are localized on both external and internal fiber surface, but not in the fiber support.

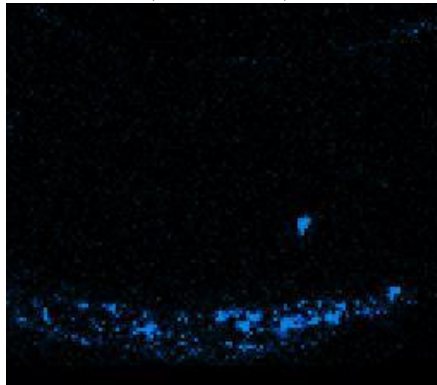
Ca Ka1

Calcium from calcium carbonate
(blue areas)

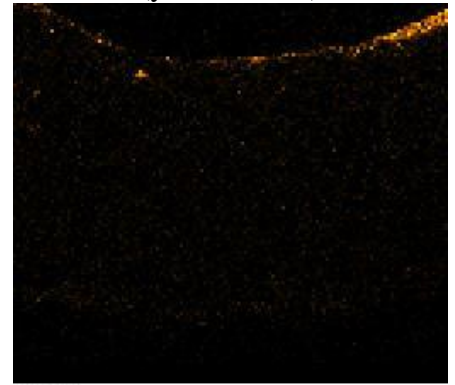
Si Ka1

Silicon from aluminosilicates
(yellow areas)

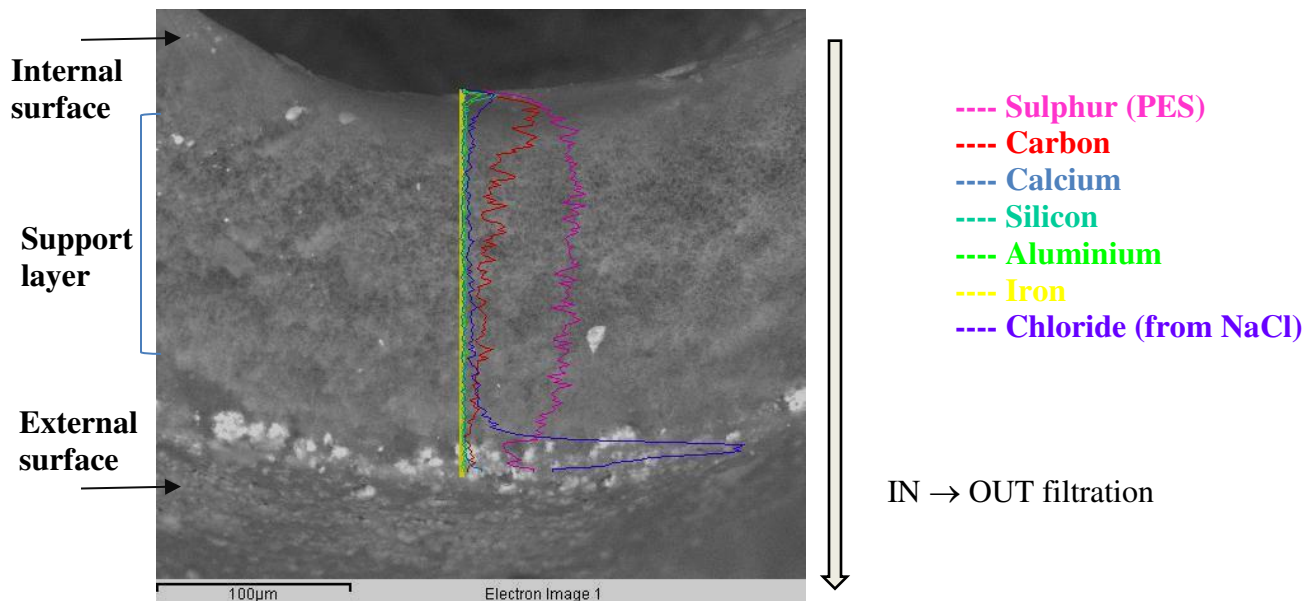
Figure 18. Elements distribution at UF hollow fiber cross section

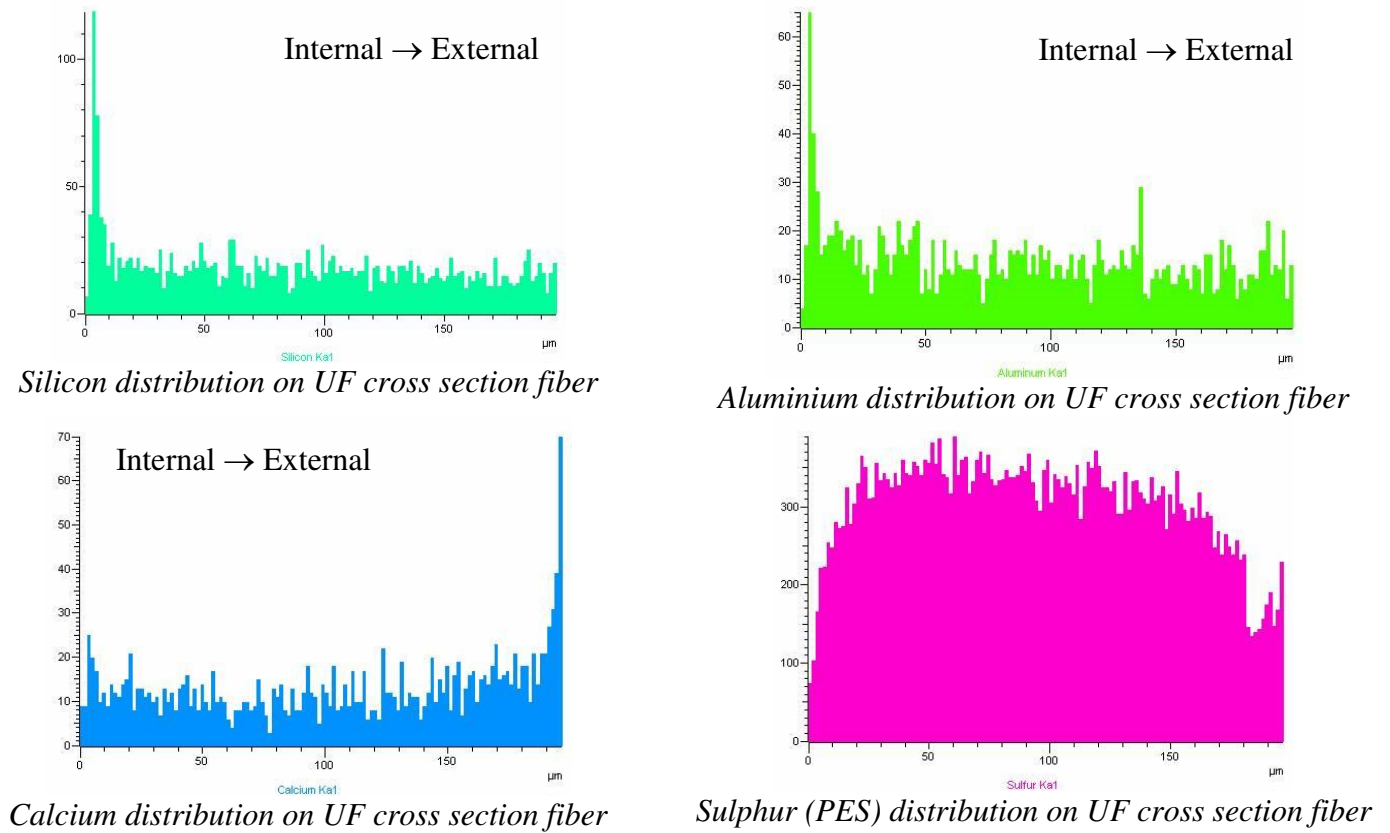
Figure 19. Elements distribution curves at UF hollow fiber cross section

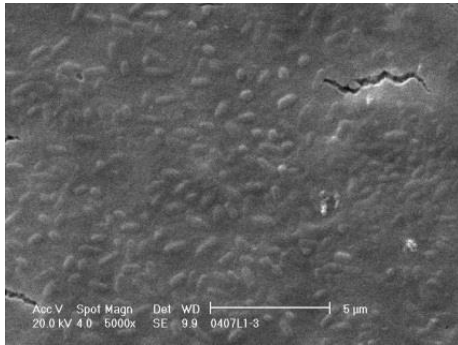
Biofilm

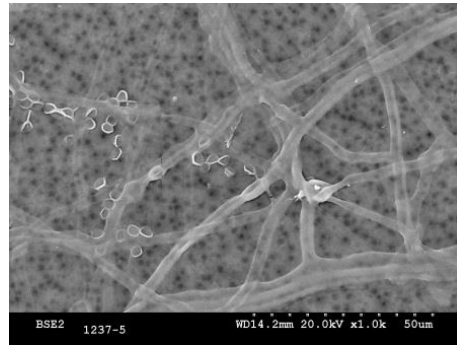
Biofilm

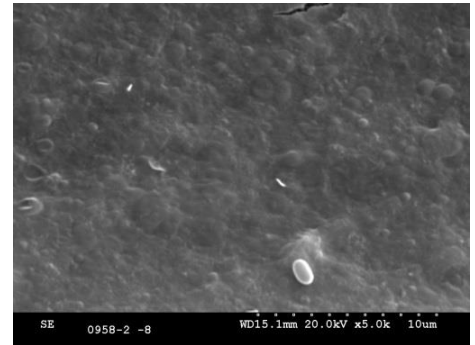
Organic

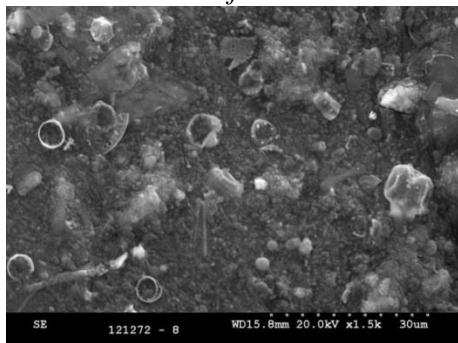
Colloidal matter

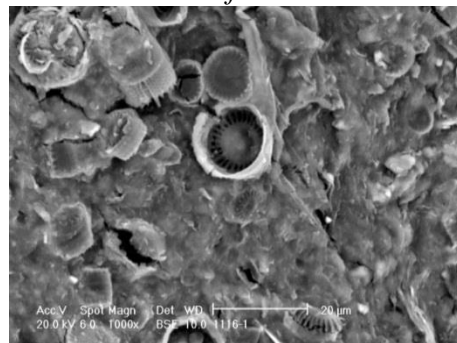
Aluminosilicates + diatoms

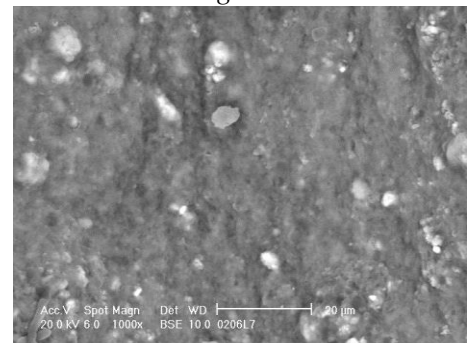
Iron

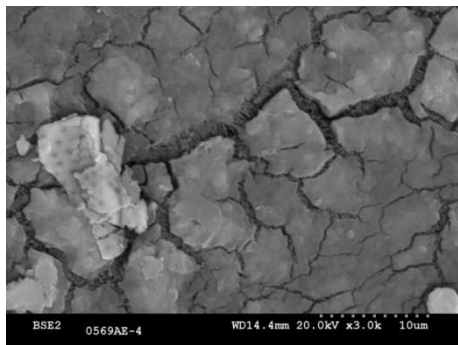
Aluminium

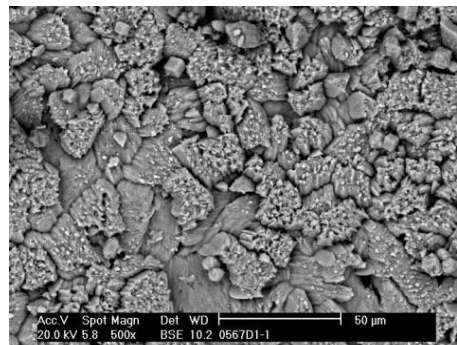
Calcium carbonate

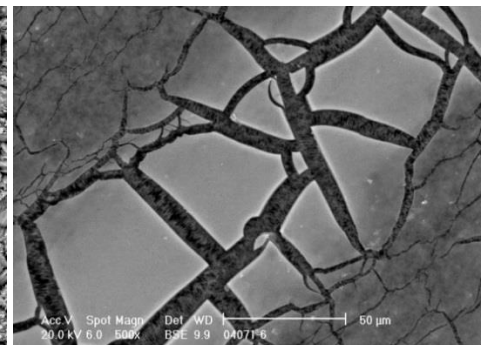
Calcium phosphate

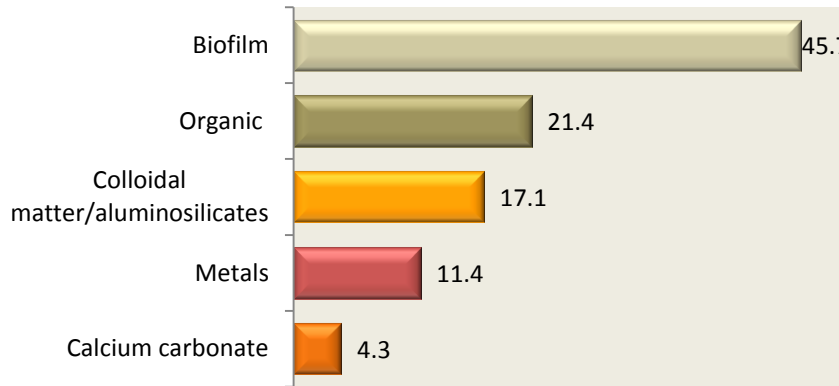
From the 90 autopsies data used for this study, nearly the 70% showed a fouling mainly organic. Besides this broad classification, figure 20 shows the different kinds of fouling detected as main component during these autopsies: biofilm and organic fouling, colloidal matter, metals (mainly iron and aluminium) and calcium carbonate. Some SEM images of the different types of fouling are included also.

Figure 20. Main kind of fouling detected as main component during UF autopsies

UF process is a barrier, which is used for the retention of water components that must be removed. Then, biofilm, organic matter and colloidal matter should be expected as main fouling components. Concerning the presence of metals, they can be also present in water but it is more common that they come from coagulants dosage. If coagulation process is optimized, these metals shouldn't reach UF membrane surface but, since it is not always possible to control water variability, UF systems must guarantee a perfect retention of these compounds.

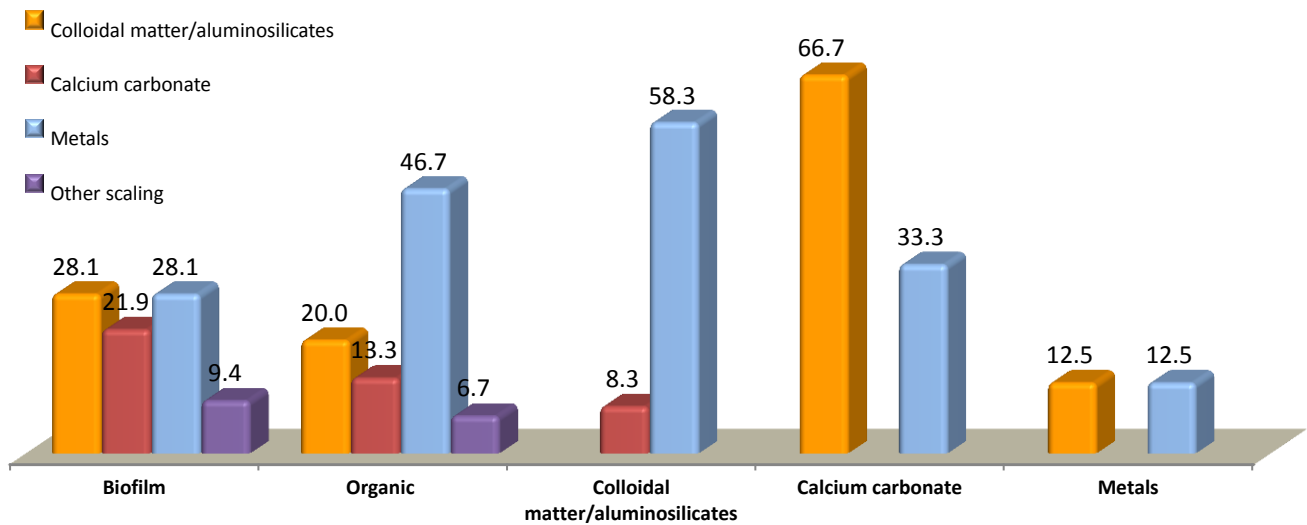
In order to help the understanding of the composite nature of fouling, figure 21 includes main secondary components detected for each kind of main fouling during autopsies.

Figure 21. Secondary components of fouling detected during UF autopsies

As it can be observed in this figure, biofilm and organic fouling show more variety of secondary fouling composition. The most common secondary component of fouling is metals, followed by colloidal matter/aluminosilicates. Besides, for the main types of fouling (organic and colloidal matter) it is common to detect also calcium carbonate as secondary component and even other scaling different that carbonates.

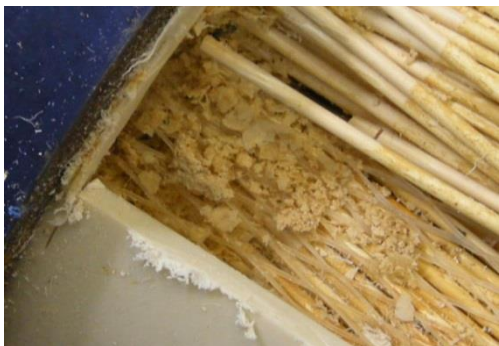
Another important factor to consider is that UF works in many systems as pretreatment for RO membranes. A scaling already formed during RO pretreatment avoids performance of antiscalant and the consequent scaling on RO system also (following photographs show a real example).

Scaling on UF support surface

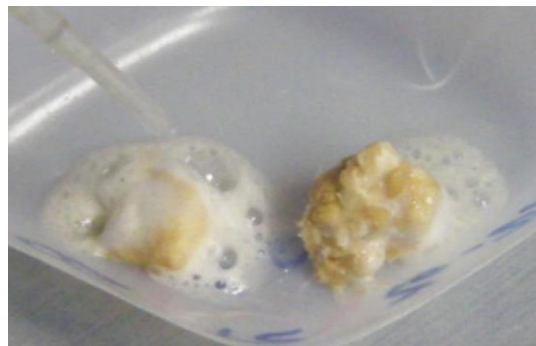
Effervescence due to carbonates presence

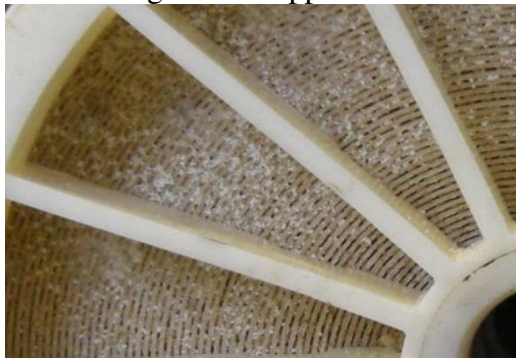
Carbonates presence of RO feed side

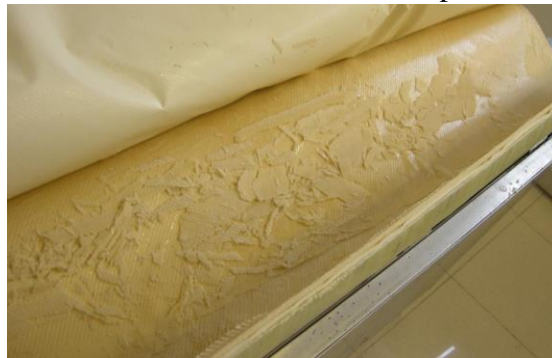
Scaling on first RO membrane position after scaled UF membrane

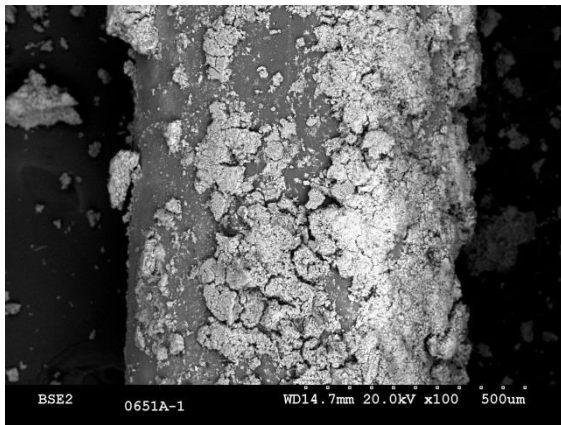
Fiber surface with scaling

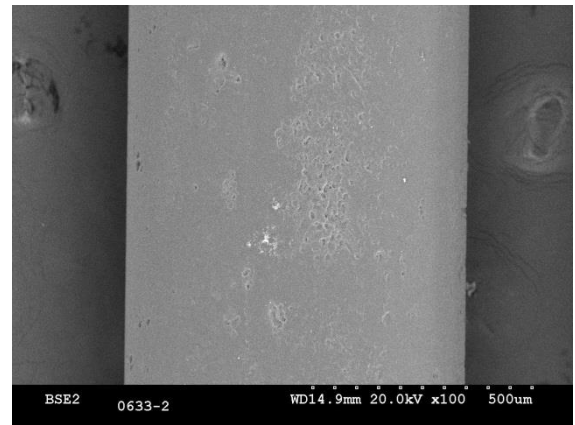
Fiber surface after cleaning

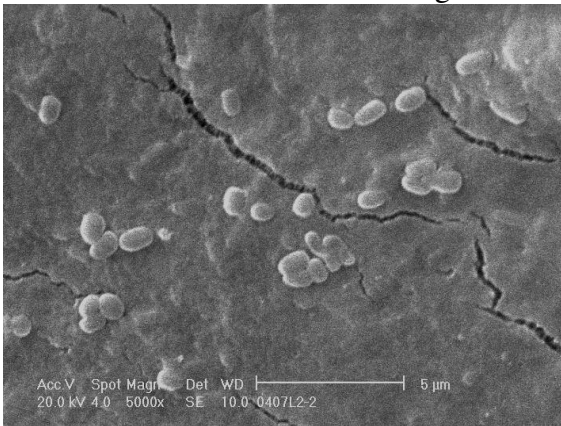
Internal surface with fouling

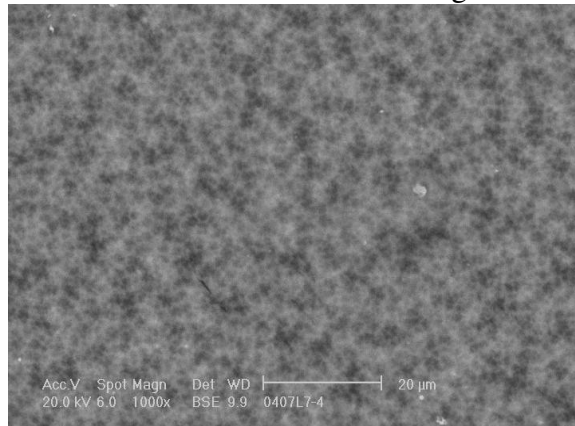
Internal surface after cleaning

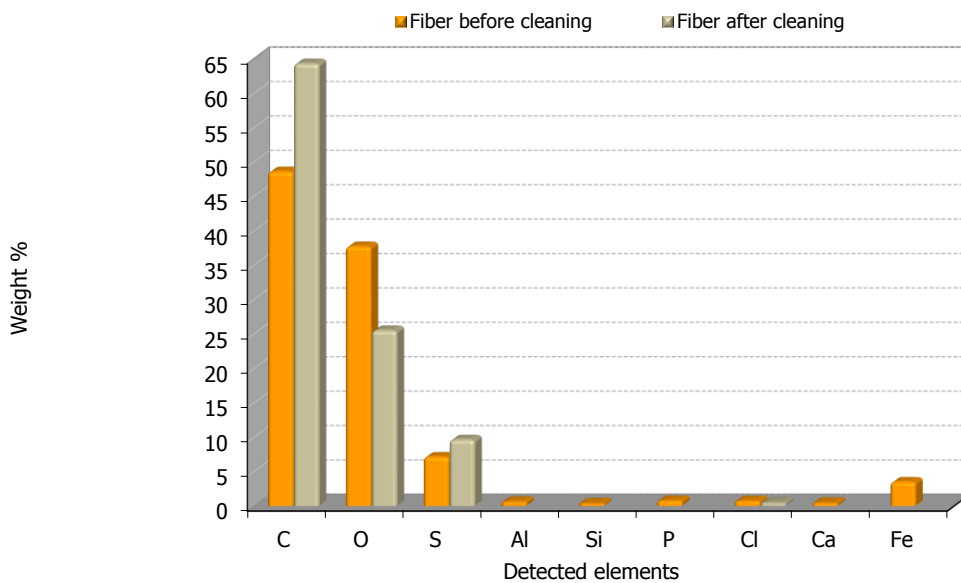
Besides the visual comparison of fiber surfaces, EDX analyses results allows to compare the percentage of elements detected during these analyses and to verify the removal of certain elements or the increase in main membrane components after cleaning process (see figure 22 as example).

Figure 22. Comparison of EDX detected elements before and after cleaning procedures

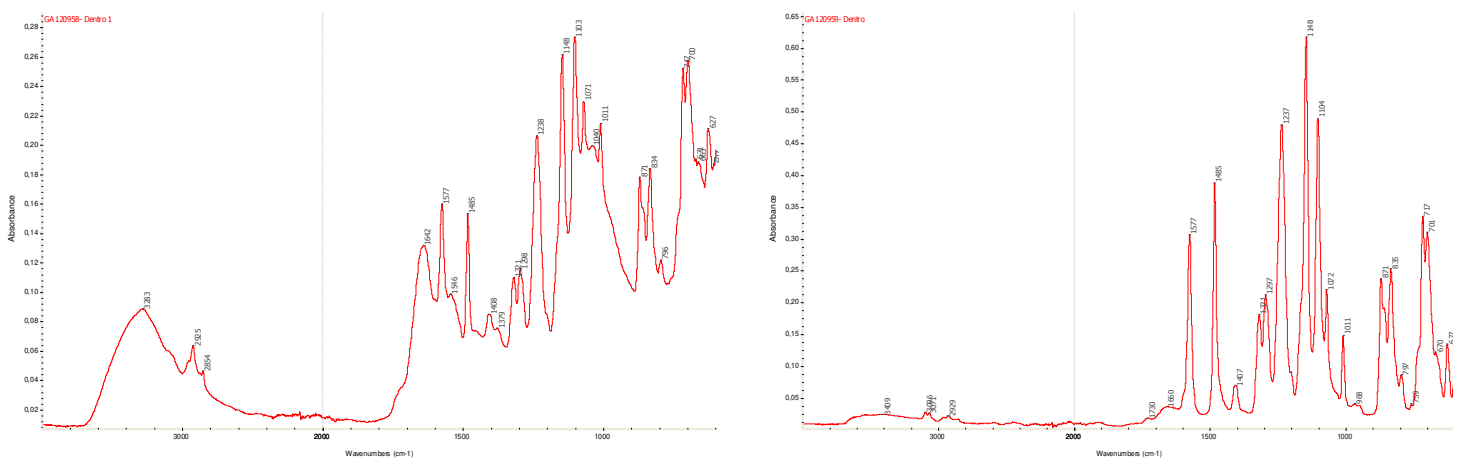
As already demonstrated for membrane and fouling identification IR spectroscopy is another useful technique to verifying cleaning effectivity in fouling removal. Following figure shows IR spectra of a fiber internal surface before and after a cleaning procedure applied in field. These analyses demonstrate the effectivity of the cleaning procedure applied in this case.

Figure 23. IR spectra of an internal UF hollow fiber Surface before (left spectrum) and after cleaning procedure (right spectrum)
