CLEANING BIOFOULED MEMBRANES EARLY IMPROVES PLANT OPERATION. COMPARISON OF AUTOPSY AND CLEANING RESULTS ON A SMALL BWRO AND LARGE SWRO.

Stephen P. Chesters, Genesys International Ltd, 3A Aston Way Middlewich, UK CW10 0HS

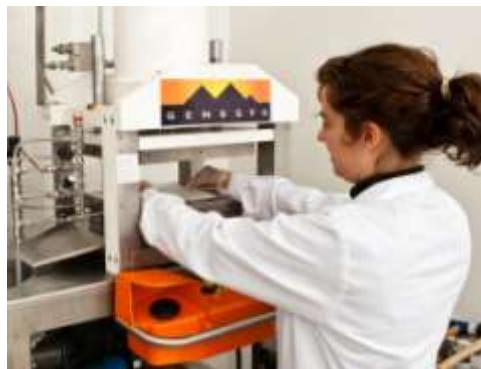
Figure 2. Flat sheet Test Rig

In most cases, membranes are sent for autopsy because they have failed or are underperforming significantly. That is salt passage, flow, flux and pressure differentials are outside of the design specifications. The first stage of membrane autopsy is to record the element model, serial number, position in the plant along with the chemical treatment regimes being applied. External examinations and photographs are taken to record the physical condition. A vacuum test is conducted to assess physical membrane damage. Samples can be taken from the feed inlet and outlet. The outer casing is removed and membrane leaves unrolled in readiness for an internal examination of the membrane sheets, glue lines, vexar and permeate carrier. Representative deposit samples are taken from the membrane surface and photographs are taken. Membrane samples are cut and prepared for characterisation and cleaning tests in a specially designed flat sheet test rig. [Fig 2] Flow rate and salt rejection are determined and compared to design specifications.

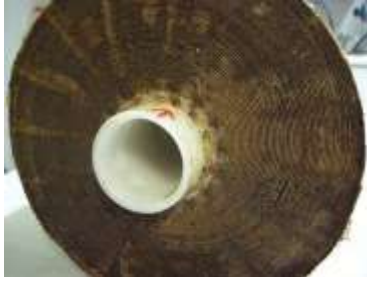
Figure 3. Deposit on feed inlet

The Ursus brewery in Buzau owned by SAB Miller is one of the biggest in Romania. The 1,200 GPM (6,500 m³/day) brackish water reverse osmosis plant is supplied via four boreholes and was commissioned in 2002. The plant operated satisfactorily for three years and then increased iron levels in the well water resulted in an increasing fouling rate. The RO plant membranes were being cleaned every month with caustic and acid membrane cleaning chemicals. Results gave only a slight decrease in differential pressure and increase in flow rate and permeate production. The membranes had to be replaced on a two year cycle. In June 2008 the plant was surveyed and a last element second stage membrane taken for autopsy. On the 26th June the autopsy report on a Dow Filmtec BW 30LE-440 was issued. The membrane weighed 22.1 kg compared with a new element weight of 15kg. The autopsy revealed a very heavy red-brown gelatinous deposit which appeared on the feed inlet (Fig 3) and throughout the feed spacer and membrane surface. Samples of deposit were taken from the membrane surface (Fig 4) and analysed using Scanning Electron Microscopy – Energy Dispersive X-ray Analysis (SEM-EDXA) techniques to determine elemental composition. The deposit consisted of iron combined with alumina-silicate (clay) and a heavy biofilm. Bacteria and oxidation tests were also conducted revealing the presence of aerobic bacteria. The membrane did not show signs of oxidation damage but flow was significantly reduced. Cleaning tests were conducted on membrane samples and a powdered high alkaline high ionic strength cleaner containing detergent, chelant and surfactants followed by a mild acid cleaner gave the best results.

In September 2008 the RO plant membranes were cleaned. A 2% solution of alkaline cleaner (pH 11.8) was made up in the CIP tank and warmed up to 38°C and circulated through the membranes. After 10 minutes the cleaning solution turned brown and cloudy and was discharged and a fresh solution made up. Following circulation for 30 minutes the solution was left to soak for 30 minutes and then flushed with permeate water. A large amount of deposits was removed so the cleaning step was repeated a third time. Samples of each cleaning solution and rinse water in Figure 6 demonstrate the progressive removal of biofilm and clay. A mild acid cleaner containing surfactants was then circulated through the membranes. The cleaning solution turned a red brown colour and fresh cleaning solution had to be made up three times circulated and flushed out. Figure 7. The cleaning process was repeated three times over the next four months until the membrane performance was restored. Subsequent cleaning cycles are now on a 6 month basis and membranes have not been replaced for four years. Historically this plant suffered gross biofilm, clay and iron fouling which had been allowed to build up over a long period; due to poor understanding of the foulants and subsequent inefficient cleaning practice. Failure to fully

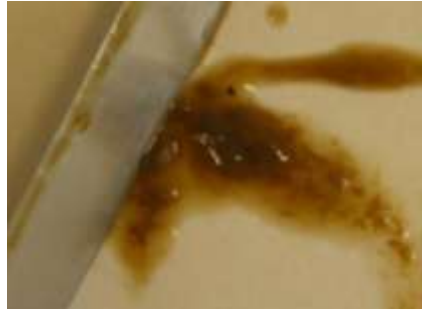
Figure 8: Gelatinous biofilm

A very large 22,000GPM (120,000m³/day) sea water RO plant in the Middle East was commissioned in October 2009. A programme of predictive maintenance was a key feature of the operation of this plant. In March 2010 a Hydranautics SWC5 RO lead membrane element from the first stage of the plant was sent for autopsy. There was no indication of any fouling present from operational data but it was felt that an autopsy would identify typical foulants that would ultimately accumulate on the membrane surfaces. A very thin gelatinous deposit was found covering the membrane surface Figure 8. Analysis of the deposit revealed it consisted of 76.9% organic material in the form of protein derivatives relating to bacteria and biofilm formation. An aerobic bacteria count showed a significant number of 7,300 colony forming units per cm². Elemental analysis of the deposit also showed the presence of iron and aluminium-silicate in the form of clay. The membrane samples were characterised using simulated sea water with pH 7.2, Conductivity 49,000 μ S/cm, and temperature of 25°C. Cleaning tests were conducted on membrane samples measuring improvement in flow rate and salt passage of a variety of cleaning chemistries. It was found that the use of a highly alkaline powder detergent and chelant (cleaner A) showed superior cleaning efficacy when compared with a more

traditional programme of biocide (cleaner B) and traditional liquid alkaline cleaner (cleaner C). The use of a warm caustic solution circulated for 2 hours showed a minor improvement in flow rate of only 2.8%. The synergistic effects of multiple chemistries and cleaning mechanisms in one cleaning compound are well recognised. [5]
