Evaluating impact of fouling on reverse osmosis membranes performance

N. Peña^{a,*}, S. Gallego^a, F. del Vigo^a, S.P. Chesters^b

Keywords: Reverse osmosis; Fouling; Autopsy

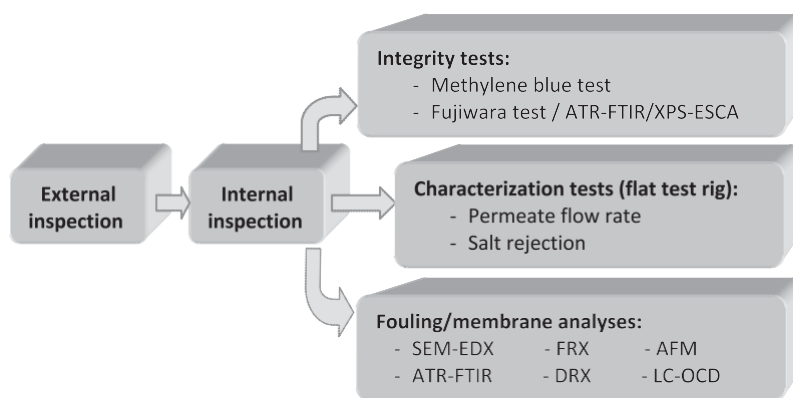
Diagram 1. Schematic description of main analysis carried out in membrane autopsies.

Membrane autopsy is considered as the main tool for identifying fouling nature and establishing membrane failures causes. Next diagram shows schematically different stages and analytical techniques commonly involved during autopsy procedure, which were already explained in previous papers [12] (see Diagram 1).

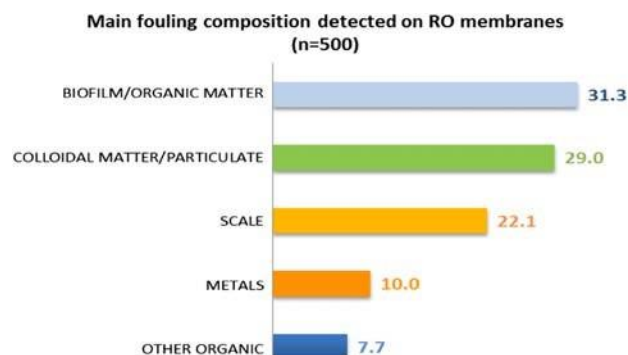
Fig. 2. Main fouling composition detected on membranes autopsies.

Biological and particulate/colloidal fouling state for 60% of the cases was reported. This fact shows the importance of pretreatment optimization in order to minimize membrane performance issues. Scaling/inorganic fouling processes have been identified as main foulant in 22% of the cases. Most commonly

detected scales are silica and calcium carbonate (summarized data in Table 1). The most common metal detected on membranes is iron, which appears as oxide when it is the main fouling, and that it is commonly found as corrosion drag when it is found as a trace. Besides as main fouling components, it is very common to detect aluminosilicates (clays) and iron on most of the analyzed membranes.

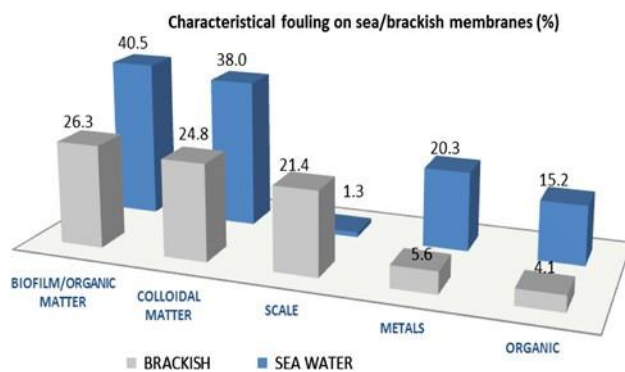
Fig. 4. Main fouling composition detected on membranes autopsies (%).

both sea and brackish water, considering other feed water sources (surface, effluents, etc.) as negligible. Fig. 4 shows a distribution of the different foulings detected on these two types of membranes. In order to provide valuable and objective conclusions, data included in this figure only considered those elements where fouling was considered as the main issue detected on the membrane and the main foulant was characterized. As it can be observed, the main two groups of fouling (biofilm and particulate/colloidal matter) appear on both kind of water as main groups of fouling. On the other side, scaling is mostly detected as main problem in brackish water and fouling seems to be more related to organic deposits and metals on sea water membranes. These results are consistent with the nature of the treated water and the historical problems found in plants.

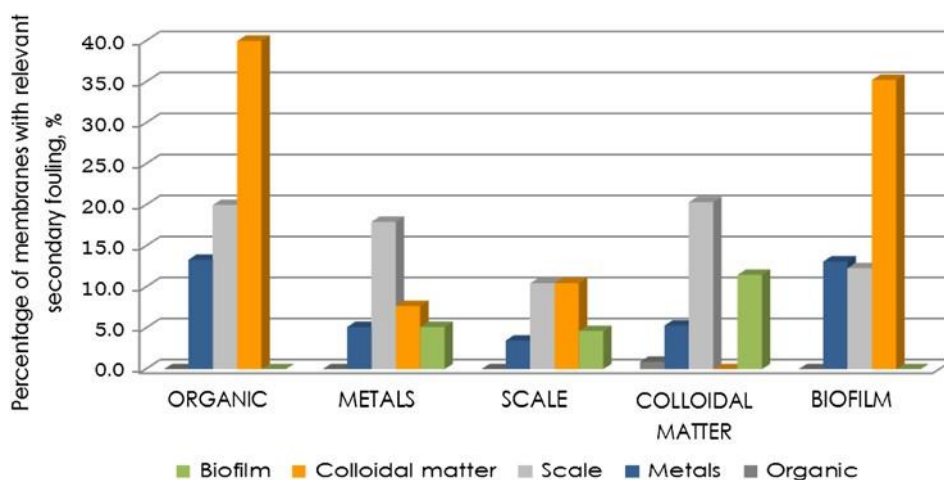
Fig. 6. Different components detected as secondary fouling vs. main fouling.

In Fig. 6, we have included the data of the secondary fouling components detected for each main group of fouling.

According to this figure, both biofilm and organic fouling are commonly accompanied by particulate/colloidal matter (aluminosilicates). However, when colloidal matter is the main component of fouling, it is more common to find scaling as secondary. On the other side, in scaling and metals fouling, the secondary component is more inorganic than organic.

Finally, Fig. 6 demonstrates that it is more usual to find a secondary component in organic foulings, probably due to their ability of retaining other components from water when they deposit on membranes surface. This last figure verifies also that colloidal matter is the most common secondary fouling found on membranes. Considering that, aluminosilicates are the second group of fouling observed as main problem in membranes, so pretreatment appears again as one of the main failures in water plant treatments.

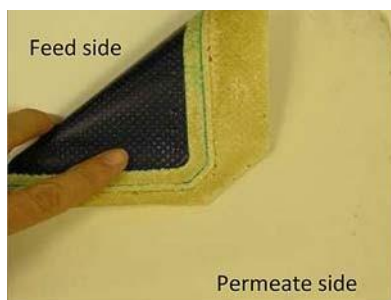
Photograph 19.- Methylene blue test negative result

section of membrane is placed in a flat sheet test rig and a blue methylene solution is recirculated through it. Blue methylene is a high molecular weight molecule that should be easily retained by polyamide, unless it is damaged. Thus, if the membrane is damaged, dye passage will be observed on the permeate side of the membrane. Next photographs 19–21 show some examples of membrane coupons after this test.

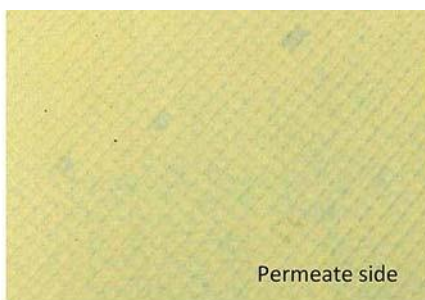
Photograph 20.- Methylene blue test positive result

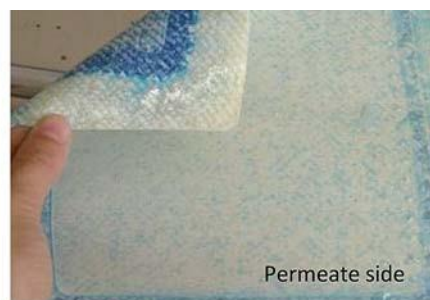
Photograph 21.- Methylene blue test massive positive result

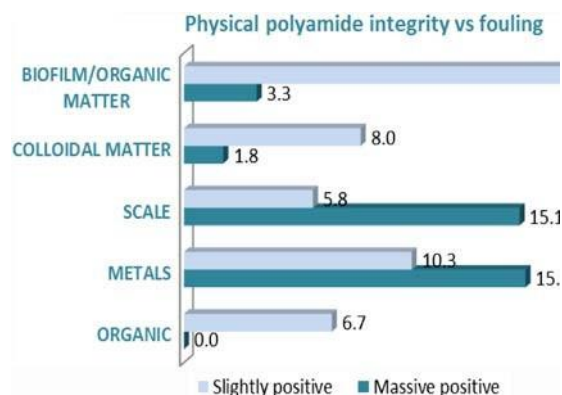
Fig. 9. Percentage of membranes with slight and severe polyamide damages vs. fouling.

Table 3 includes the percentage of membranes with positive results in methylene blue tests. As it can be observed, except for membranes with organic fouling, most of the membranes show damages in some way on polyamide layer. As expected, scales are the fouling category with majority of damaged elements. By the way, how these damages affect membrane performance will depend on how relevant those damages are. So, it is important to take in account when positive results were slight or massive. Thus, Fig. 9 dem-

onstrates that on membranes with biofilm and organic fouling, it is more frequent that damages are slight, meanwhile for scaling and metals, there is a higher percentage of membranes were this damage is massive.
