Evaluating impact of fouling on reverse osmosis membranes performance

N. Peña^{a,*}, S. Gallego^a, F. del Vigo^a, S.P. Chesters^b

Keywords: Reverse osmosis; Fouling; Autopsy

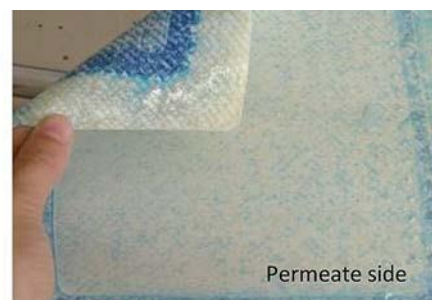
section of membrane is placed in a flat sheet test rig and a blue methylene solution is recirculated through it. Blue methylene is a high molecular weight molecule that should be easily retained by polyamide, unless it is damaged. Thus, if the membrane is damaged, dye passage will be observed on the permeate side of the membrane. Next photographs 19–21 show some examples of membrane coupons after this test.

Photograph 21.- Methylene blue test massive positive result
