Problems of operation and main reasons for failure of membranes in tertiary treatment systems

Abstract This paper presents and discuss the results of the long term operation and monitoring of membrane fouling at several full-scale MF/RO water recycling facilities operated by Agbar in Spain. It was demonstrated that membranes are very reliable treatment enabling the production of high-grade recycled water, well disinfected and with the removal of all priority substances. The high organic and salt concentrations of raw wastewater combined to extremely high variations justified the implementation of sand filtration to protect MF/RO membranes. Membrane autopsy was used to better understand the predominant fouling mechanisms and optimise down-stream operation and membrane cleaning strategy. The main membrane pathologies are described with recommendation of an adequate cleaning strategy.

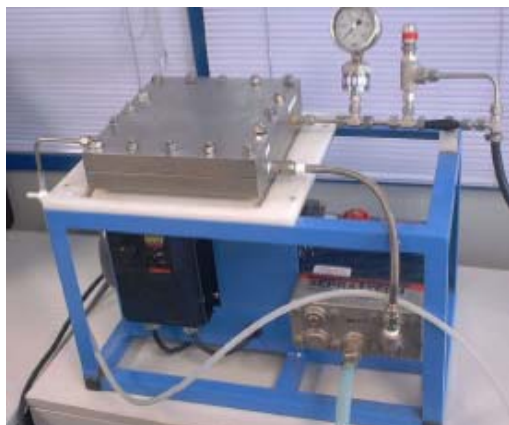
Figure 1. View of the flat sheet cleaning rig used for membrane autopsy

Several samples of aged and/or fouled RO membranes situated either in the 1st and 2nd stages have been removed for an autopsy in a specialised laboratory. After external inspection, the first step consists in removal of various A4-size pieces of RO membranes, which were characterised by means of the flat sheet- test rigs under standard operating pressure, saline solution and flux conditions settled by membrane manufacturer (Figure 1). In some cases, once preliminary studies have been completed, supplementary test works were performed on a full size element.

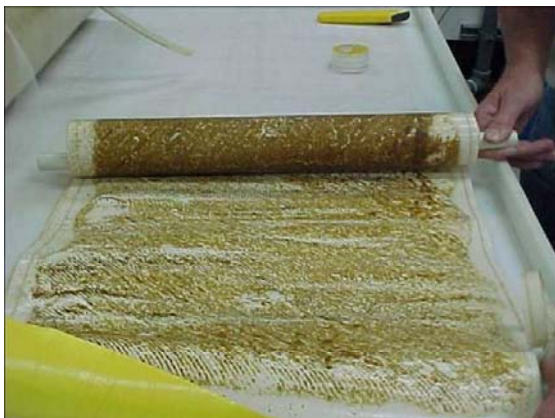
Figure 8. Example of a biological/organic fouling

Biological/Organic fouling. The most typical causes for biological and organic fouling are usually related to improper membranes preservation, presence of biological and organic matter in the feed water and/or improper pre-treatment. This type of fouling (Figure 8) can be recognized by the strong odour of the elements, by the discoloration of the scroll end, as well as by the low permeate flow, high salt rejection and high pressure drop. A commonly recommended biofouling cleaning solution consists of a 0.5-1% (wt) Na-EDTA and 0.1% (wt) NaOH, pH 12 and 30°C. Contact time

is critical and several overnight soaks might be necessary to restore the system performance. (Dow Water Solutions, Technical Manual).
