## Evaluating impact of fouling on reverse osmosis membranes performance

*Keywords:* Reverse osmosis; Fouling; Autopsy

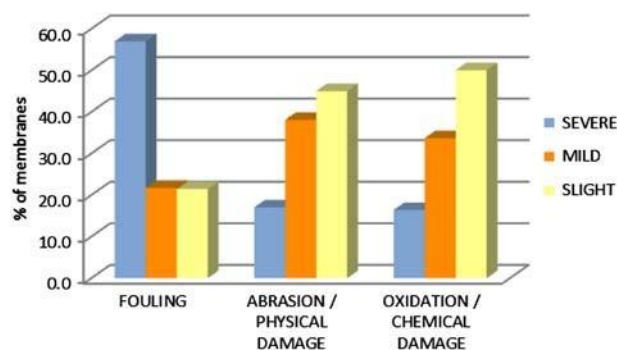
Fig. 1. Main membrane failures detected from membrane autopsies.

Main causes of membrane failures can be classified into three categories: fouling, physical damage/abrasion, and chemical damage, which include oxidation processes. As explained previously, fouling is considered by both plant operators and researchers as one of the main reasons for membrane failure and deviations on expected performance. Data achieved in over 500 membrane autopsies recognize that severe fouling processes are considered as the main reason for membrane fouling in almost 60% of studied membranes, as shown in Fig. 1. However, chemical and physical damages appear as mild or slight failures. Although these data demonstrate that fouling is the main problem detected on membranes, this does not mean that it is the worst situation facing RO systems failures. Meanwhile in most of the cases, fouling can be

removed from membranes surface with chemical cleanings, both abrasion and oxidation are irreversible damages that make impossible to recover reference performance parameters. In any case, an effective fouling removal mainly depends on an accurate identification and on a fast application of cleaning procedures.

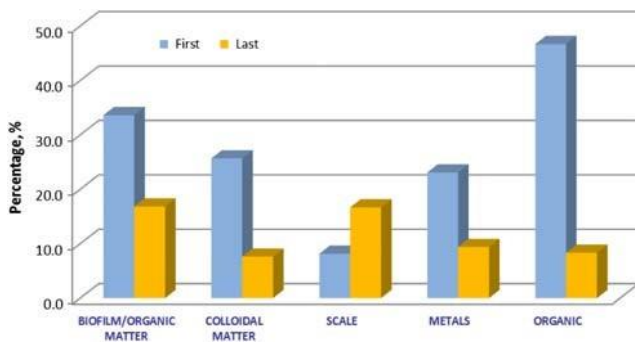
Fig. 3. Percentage of membranes detected on different plant positions vs. fouling group.

In order to review membrane position effect on fouling tendencies, data were analyzed separately for those membranes in the first and last positions. Data achieved are shown in Fig. 3 and verifies that most of the fouling groups appear at first position, except inorganic/scaling foulants, which are most frequent on last position. Nevertheless, it is also clear from data collected in this review that in some cases certain types of foulants can be detected in different positions than expected.

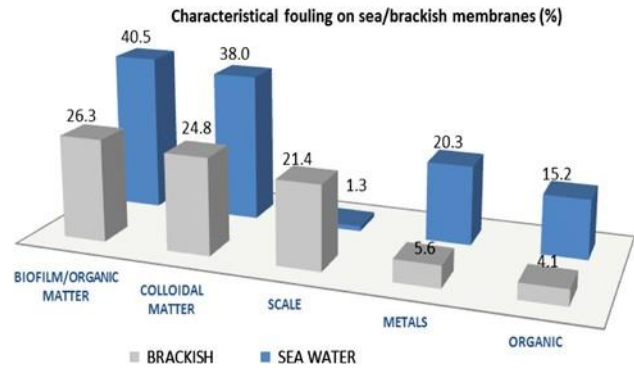
Fig. 4. Main fouling composition detected on membranes autopsies (%).

both sea and brackish water, considering other feed water sources (surface, effluents, etc.) as negligible. Fig. 4 shows a distribution of the different foulings detected on these two types of membranes. In order to provide valuable and objective conclusions, data included in this figure only considered those elements where fouling was considered as the main issue detected on the membrane and the main foulant was characterized. As it can be observed, the main two groups of fouling (biofilm and particulate/colloidal matter) appear on both kind of water as main groups of fouling. On the other side, scaling is mostly detected as main problem in brackish water and fouling seems to be more related to organic deposits and metals on sea water membranes. These results are consistent with the nature of the treated water and the historical problems found in plants.

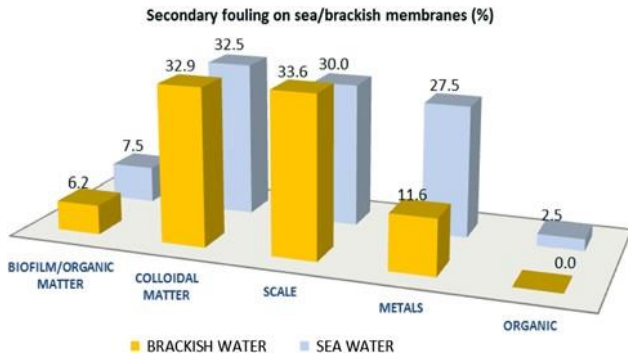
Fig. 5. Secondary fouling composition detected on membranes autopsies (%).

type of membrane, are graphically represented in Fig. 5. This figure verifies that, although some charac-

teristic components are not present on membranes as main foulants (e.g. scaling on sea water membranes), they may be present as secondary components. As figures show, secondary components are mainly inorganic for both kinds of water/membranes. In sea water, special attention should be paid to the presence of metals, since it is a clear consequence of corrosion processes.

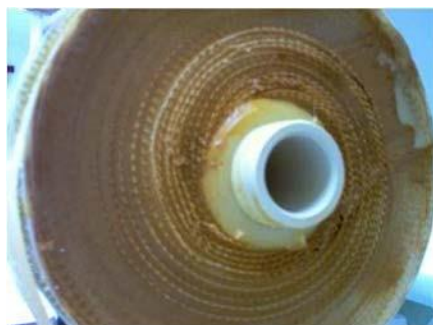
Photograph 16.- Spacer protrusion

Table 2 includes the percentage of membranes with spacer protrusion for each group of fouling detected. As these results demonstrate, spacer protrusion was detected on every type of fouling, although the highest percentage of membranes with this problem was for biofilm. In membranes with biofilm, it is very common to find a relevant presence of the fouling on spacer, which contributes to material displacement (see photographs bellow) and increase in DP. The presence of fouling on spacer material can be found also in scaling processes (as shown in photograph 18).

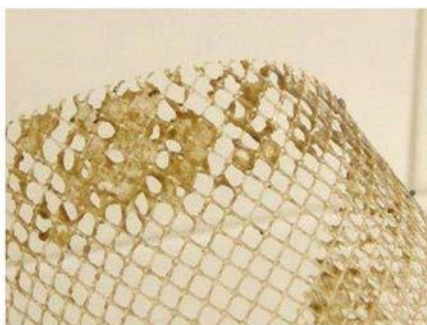
Photograph 17.- Biofouling on spacer

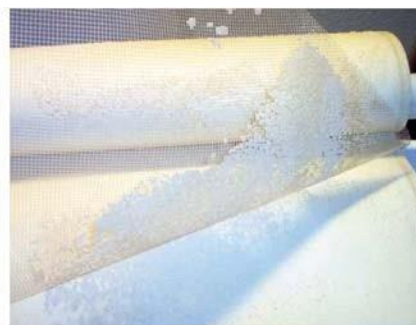
Photograph 18.- Calcium Sulphate scale on spacer

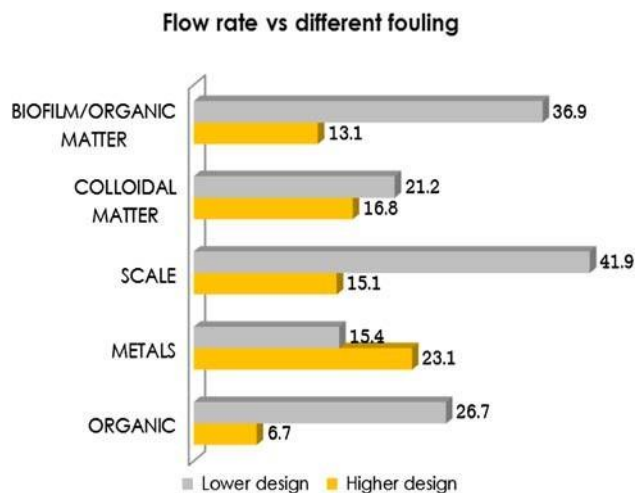
Fig. 7. Flow rate vs. fouling.

Fig. 7 represents the variation of flow rate depending on the fouling detected on the membrane surface and Fig. 8 corresponds to the percentage of membranes with poor rejection values detected for each

Scaling is the group of fouling with a higher percentage of membranes with low flow (40%) and, on the other side, it is also the group that shows the highest percentage of membranes with effect on rejection values. On the rest of fouling groups, only biological and organic fouling categories show a higher percentage of membranes where lower flow values were detected rather than higher, as particulate/colloidal matter and metals have a higher percentage with higher flux.

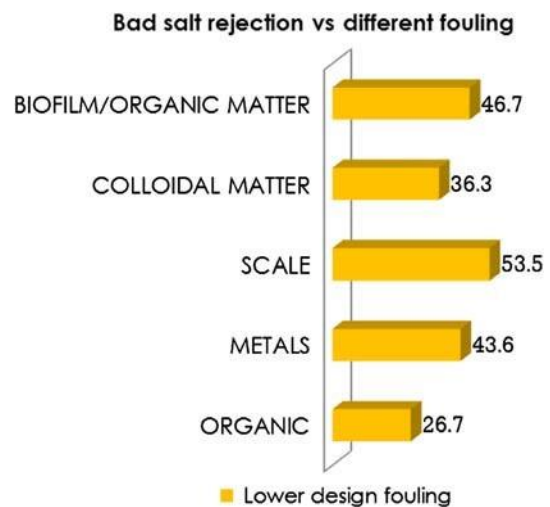
Fig. 8. Salt rejection vs. fouling.

Concerning salt rejection, the 59% of the analyzed membranes with a severe problem of fouling showed poor rejection values. Fig. 8 shows that all the fouling categories can be related to decreased rejection properties. A bad rejection performance can be due to both the presence of fouling and the poly-
