RESULTS FROM 99 SEAWATER RO MEMBRANE AUTOPSIES

Authors: *Stephen P. Chesters, Nuria Pena, Silvia Gallego, Maqsood Fazel, Matthew W. Armstrong, Fernando del Vigo*

Presenter: *Stephen P. Chesters*
Managing Director – Genesys International Limited – UK

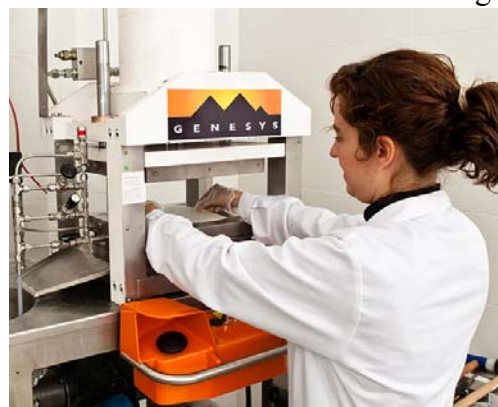
Fig 1 Flat sheet test rig

designed flat sheet test rig. [Fig 1] Flow rate and salt rejection are determined and compared to design specifications. Physical damage to the membrane samples is conducted using the methylene blue dye test and oxidation by halogens is tested using the Fujiwara test. The validity of the Fujiwara test has been questioned in some quarters so additional tests using attenuated total reflectance infrared spectroscopy (ATR/FTIR) is carried out. This can provide valuable information related to the chemical structure of membrane and deposits. In the mid-infrared, absorption of radiation is related to fundamental vibrations of the chemical bonds. Internal reflection spectrometry provides information related to the presence of specific functional groups which can determine the presence of halogens. Deposits are identified using elemental determination with the SEM-EDXA system. This is based on analysis of X-rays produced via electron beam excitation of a sample area. This technique allows analysis of a sample in selective areas. The limited depth of analysis (typically a few microns), and the possibility to select the area of interest under the electron beam, allows for local analysis to reveal differences in composition. The identification and measurement of individual peak intensities in the X-ray spectrum can be done with a computerized multichannel analyzer. In addition X-Ray diffraction is carried out to identify crystalline solids by measuring the characteristic spaces between layers of atoms or molecules in a crystal. Each crystalline solid has its unique characteristic X-ray powder pattern which may be used as a "fingerprint" for its identification. X-ray photoelectron spectroscopy analysis (XPS) or electron spectroscopy for chemical analysis (ESCA) is a quantitative spectroscopic technique that measures the empirical formula, chemical state and electronic state of the elements that exist within a material. XPS spectra are obtained by irradiating a material with a beam of X-rays while simultaneously measuring the kinetic energy and number of electrons that escape from the top 1 to 10 nm of the material being analyzed. When the nature of the deposits on the membrane surface is understood then several membrane samples are cleaned with a variety of cleaning solutions at different pH and temperature to assess the best method for cleaning the plant. A full cleaning protocol can then be recommended. The autopsy is written up as a complete report and forwarded to the customer.

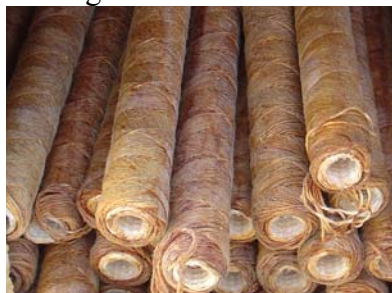
chloride [AlCl_3], Aluminium sulphate [alum, $\text{Al}_2(\text{SO}_4)_3$], Polyaluminium chloride [PAC]. The Israeli Ministry of the Environment has voiced concerns that 3,000 tons of iron per year will be discharged into the sea as a result of coagulant use on desalination plants. Iron fouling has a damaging effect on both cartridge filters and membranes as shown in Fig 3 & Fig 4.

Fig 3 Iron fouled cartridge filters

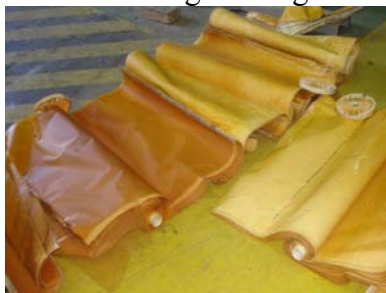
Fig 4 Failed membranes

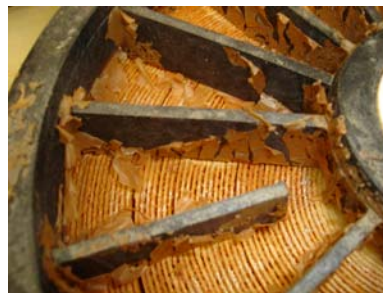
Fig 5 Iron acrylate fouling

The use of phosphonate based antiscalants is common place in SWRO plant as they have the distinct advantage of sequestering iron and preventing deposition on the membrane surface. The choice of antiscalant is critical as polymer based products react with iron to form iron acrylate which blinds and irreparably damages the membrane as seen in Fig 5. The autopsy deposit analysis frequently showed small quantities of transition metals such as titanium, vanadium, chromium, manganese, cobalt, nickel, copper and molybdenum. It was reported by Murphy [10] that deacetylation (of CA membranes) was more effective in presence of cobalt and ruthenium, moderately in the presence of iron, nickel, rhodium, palladium and silver, and slightly in presence of copper and gold salts. The source of these metals is thought to be as a result of plant corrosion but may also be due to impurities found in iron salt coagulants. Work conducted by Dr. Nabil Nada of SWCC demonstrated an increased likelihood of membrane oxidation when using poor grade ferric chloride coagulant due to the presence of transition metals which catalysed the oxidation reaction.

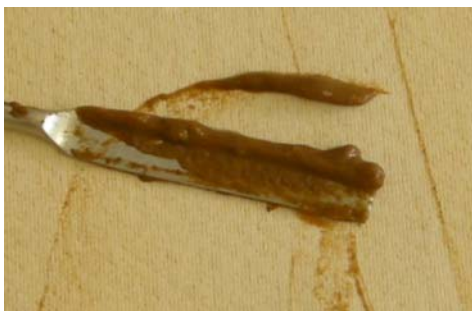
Alumino-silicate fouling was found in one third of the sea water membranes autopsied. Ten percent of membranes were failing primarily due to clay deposition [Fig 9]. Clay is the by-product of chemically weathered rocks and is ubiquitous in all waters around the world. Clay minerals are part of the Phyllosilicate (sheet structures) subclass of minerals. Structurally they are composed of tetrahedron rings linked by shared oxygen atoms to other rings in a two dimensional plane forming a sheet-like structure [Fig 10]. These sheets are connected to each other by weakly bonded layers of cations which often have water and other neutral atoms or molecules trapped between the sheets giving clay their soft compressible nature. The resultant crystal structure is flat and plate like. According to Swaddle [11] we refer to them as aluminosilicates when some of the Si^{4+} ions in the silicates structure are replaced by Al^{3+} ions. For each Si^{4+} ion replaced by an Al^{3+} , the charge must be balanced by having other positive ion such as iron, magnesium, alkali metals, alkaline earths and other cations. Armstrong [12] concluded that “The structural characteristics of clay minerals mean that operational increases in pressure can compress the deposit resulting in further loss of membrane flux. The test data supports the fact that clay deposits on a membrane surface can produce irreversible damage in terms of salt rejection due to abrasion processes. Improvements in pre-treatment can be considered although practical experience shows that small particulate/colloidal matter ($< 2 \mu\text{m}$) cannot be completely removed from feed streams.” Clay is very difficult to remove completely from the feed stream through filtration. A build up is almost inevitable therefore regular cleaning with specialised clay cleaners is recommended. Clay fouling can be minimized by improving media filters, microfilters and using appropriate flocculants.

Fig 9 Clay fouling on a membrane
