Problems of operation and main reasons for failure of membranes in tertiary treatment systems

Abstract This paper presents and discuss the results of the long term operation and monitoring of membrane fouling at several full-scale MF/RO water recycling facilities operated by Agbar in Spain. It was demonstrated that membranes are very reliable treatment enabling the production of high-grade recycled water, well disinfected and with the removal of all priority substances. The high organic and salt concentrations of raw wastewater combined to extremely high variations justified the implementation of sand filtration to protect MF/RO membranes. Membrane autopsy was used to better understand the predominant fouling mechanisms and optimise down-stream operation and membrane cleaning strategy. The main membrane pathologies are described with recommendation of an adequate cleaning strategy.

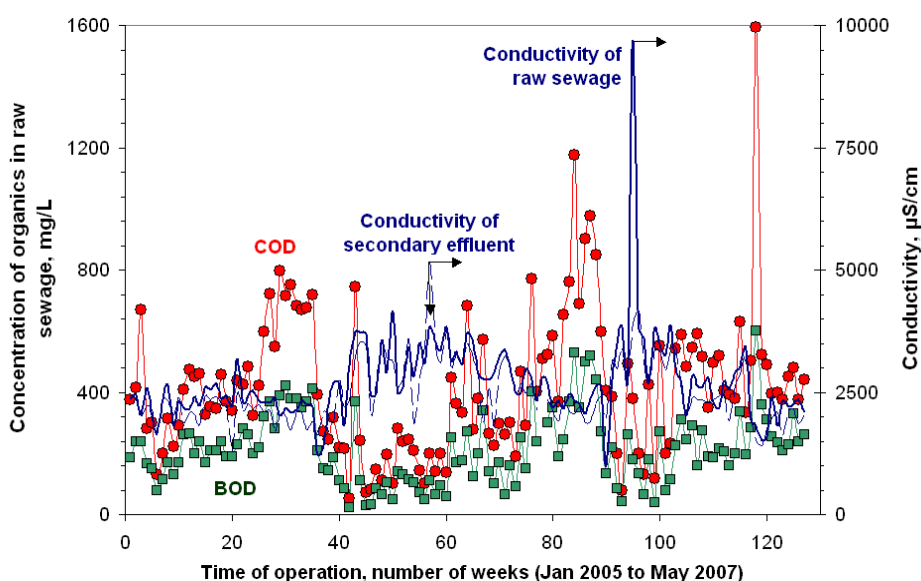
Figure 2. Evolution of organic content and salinity of raw wastewater

It is important to underline that raw wastewater treated in these two recycling facilities is very concentrated in terms of organic and nitrogen concentrations. In addition, wastewater salinity is extremely high with peak concentrations up to 5,700-9,400 $\mu\text{S}/\text{cm}$ (see Figure 2). High salinity is due to sea water intrusion in sewers favoured by specific climate conditions.

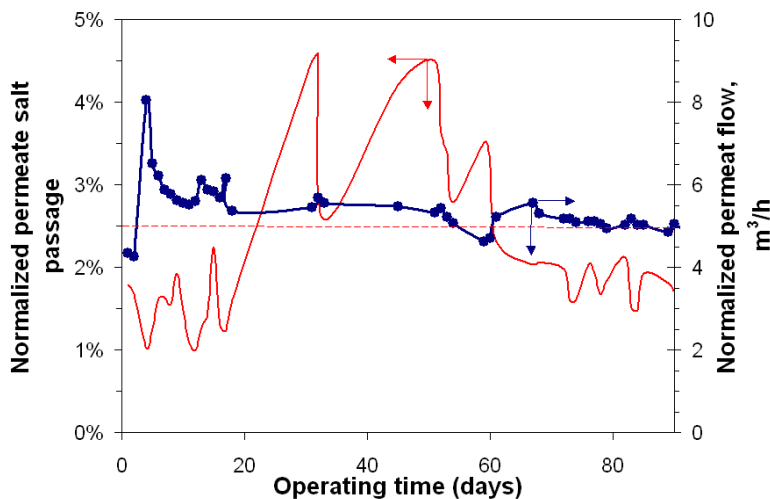
As illustrated by Figure 3, deterioration of water quality (variation of salinity from 1734 to 3142 $\mu\text{S}/\text{cm}$) leads to a significant decrease in membrane flux combined to increase in salt passage above 2.5% (average RO recovery 72%).

Figure 3. Performance of polyamide RO membranes

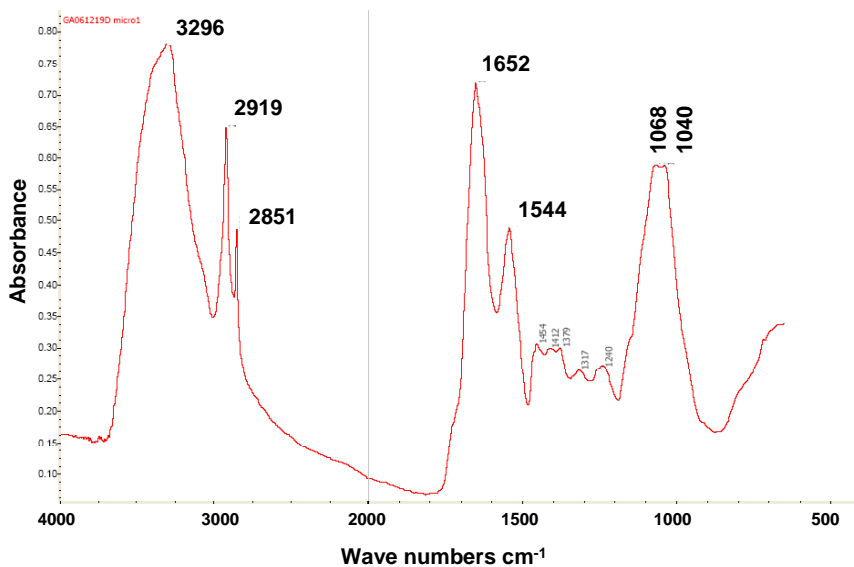
The infrared spectra (Figure 7) demonstrated that this fine layer is composed predominantly by proteins, which could correspond to an early stage of biofilm development (surface conditioning by excreted soluble proteins).

Figure 7. Infrared spectrum of the fine layer on the membrane surface

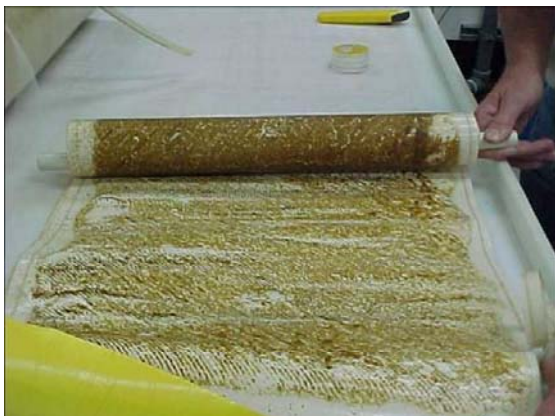
Figure 8. Example of a biological/organic fouling

Biological/Organic fouling. The most typical causes for biological and organic fouling are usually related to improper membranes preservation, presence of biological and organic matter in the feed water and/or improper pre-treatment. This type of fouling (Figure 8) can be recognized by the strong odour of the elements, by the discoloration of the scroll end, as well as by the low permeate flow, high salt rejection and high pressure drop. A commonly recommended biofouling cleaning solution consists of a 0.5-1% (wt) Na-EDTA and 0.1% (wt) NaOH, pH 12 and 30°C. Contact time

is critical and several overnight soaks might be necessary to restore the system performance. (Dow Water Solutions, Technical Manual).
